Returning Rapids

Fall Trip Findings

September and October 2023

2023 was a very dynamic year for Cataract Canyon. In September and October, the Returning Rapids Project (RRP) completed three Cataract Canyon research trips and one North Wash-based survey effort. This year, RRP has continued to monitor changes, build a data set, and communicate the story of what we are observing along this section of the Colorado River.

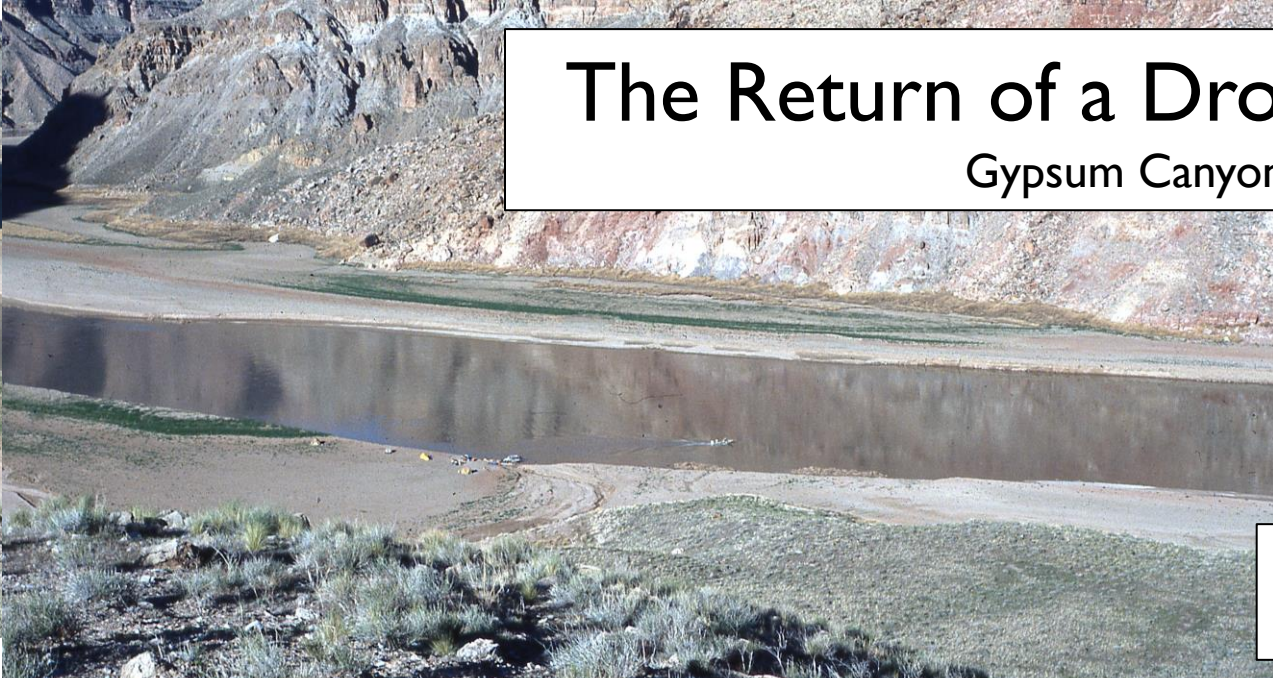
Photos from Gypsum Canyon area
stitched together
Bill Noonan Collection, early 1980s

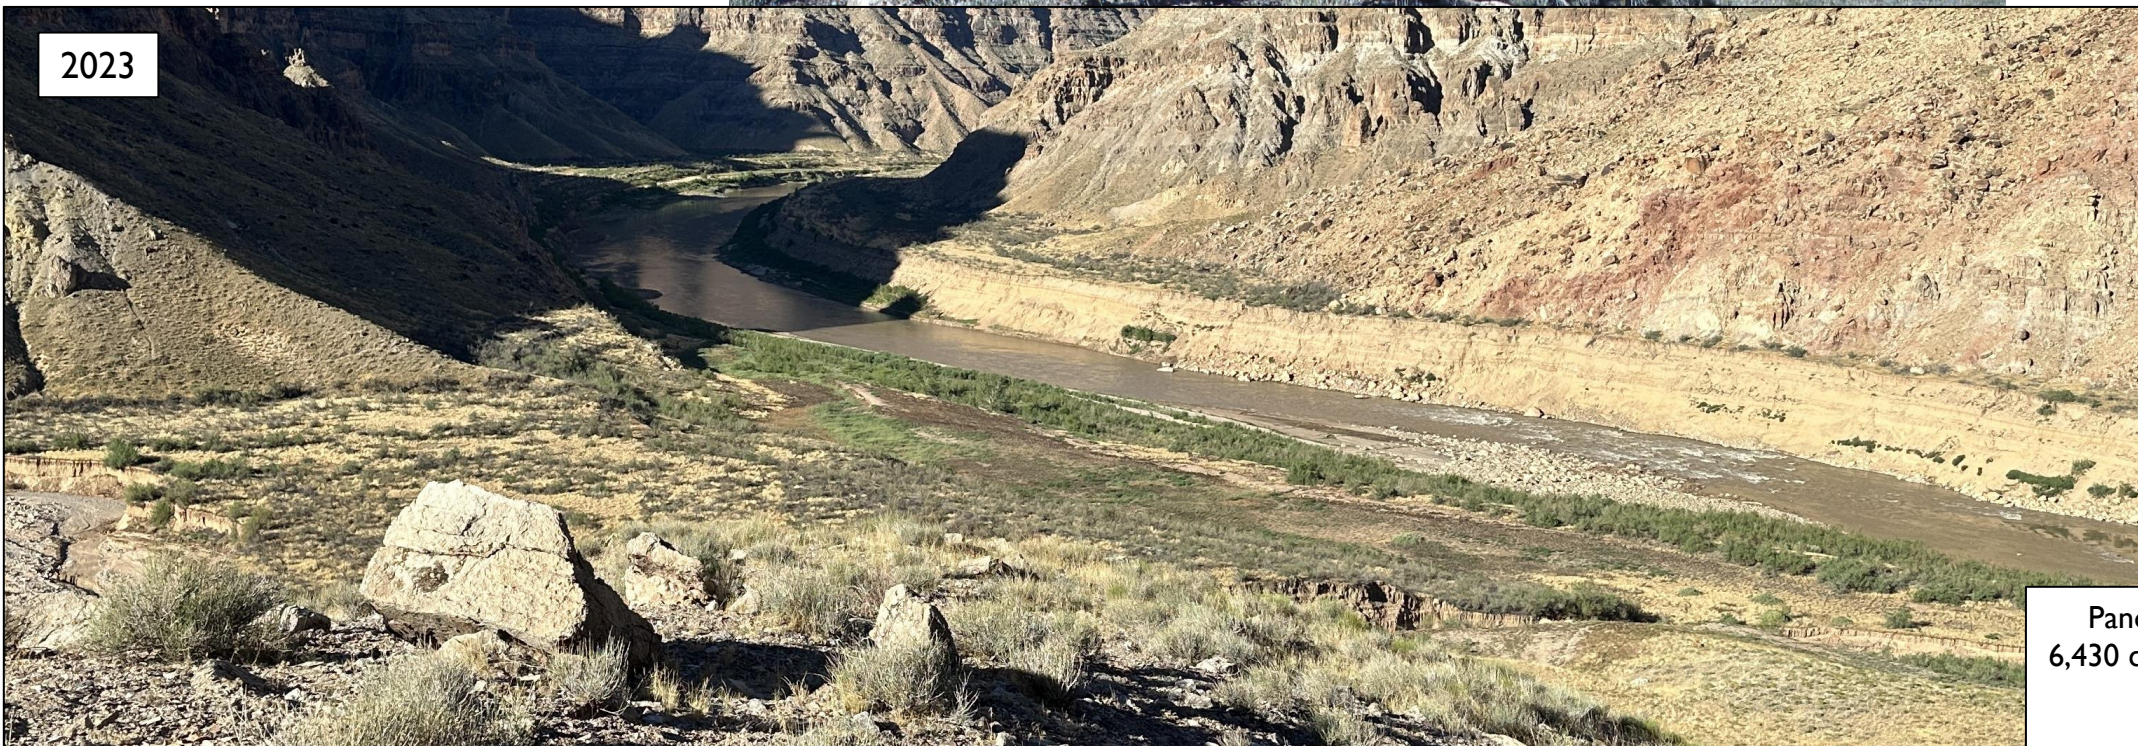
Panorama of Gypsum Canyon
6,430 cubic feet per second (cfs),
bridge gauge 3,577 feet,
9-5-2023, Mike DeHoff

For years, RRP has observed the slow return of Gypsum Canyon Rapid. As the reservoir has receded, the river has scoured out the sediment. Slowly, more gradient and obstacles have appeared.

During the latter half of the summer of 2023 and into the fall, trips started to tell stories of swimmers in Gypsum Canyon Rapid and of boats getting thumped by a new hole near the end of the returning rapid.

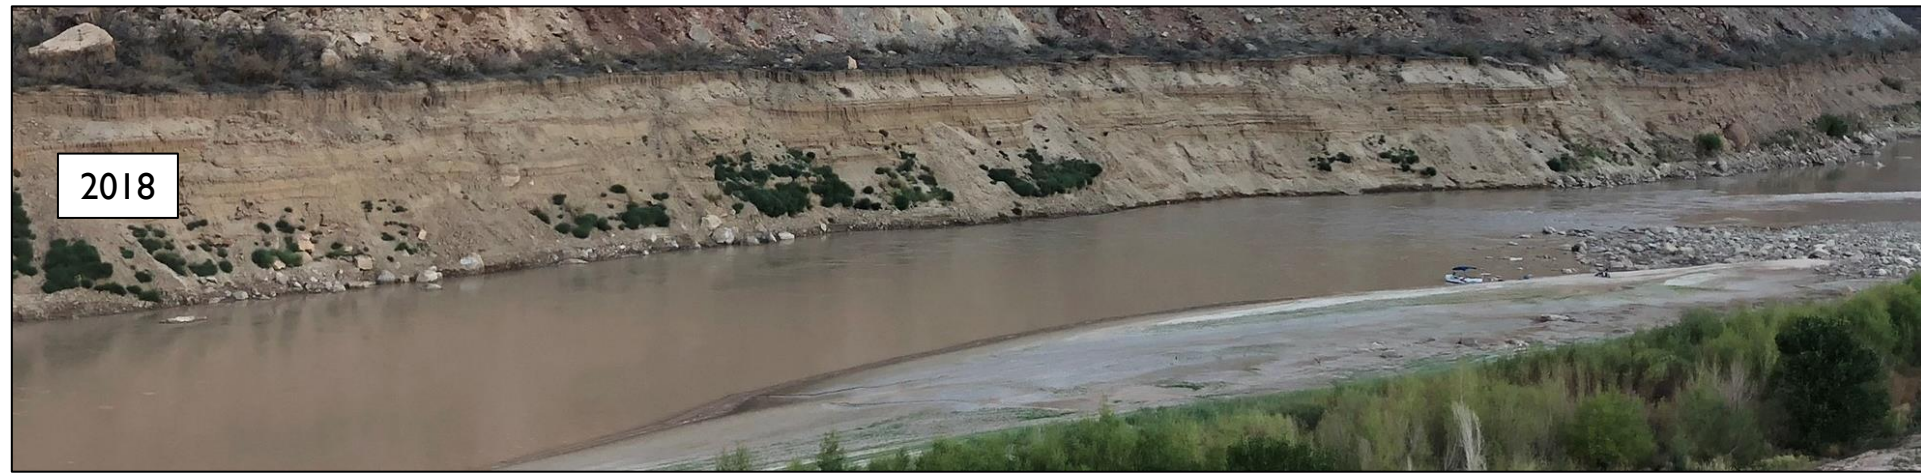
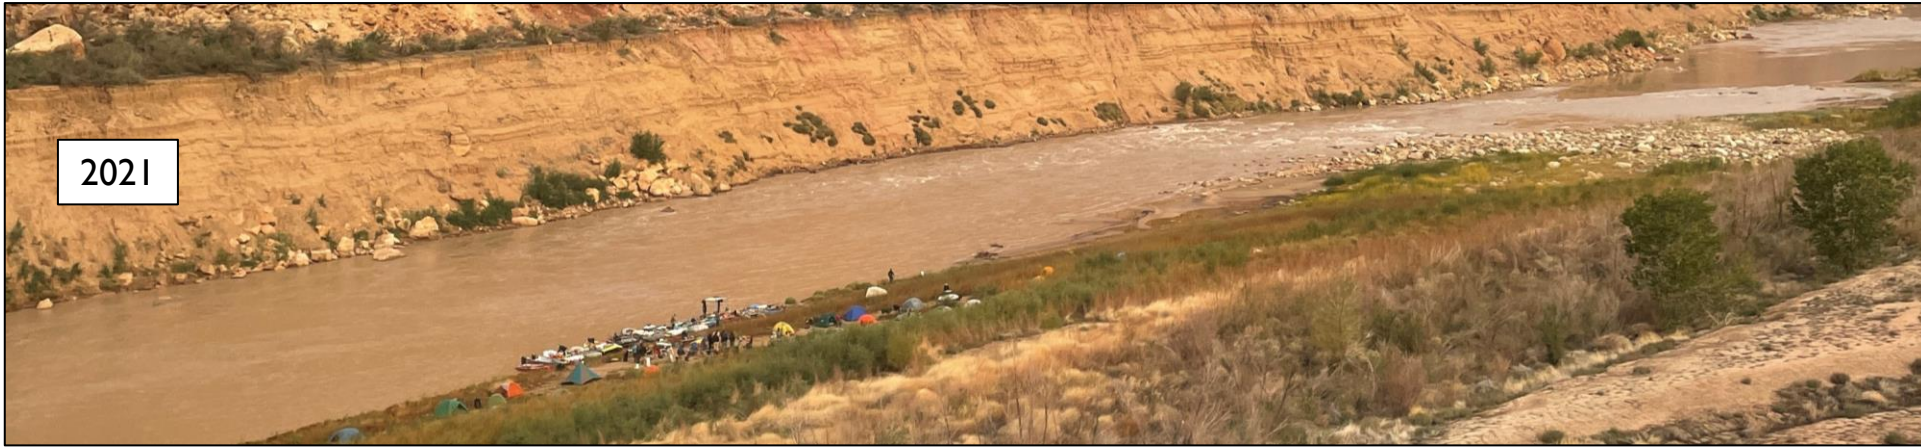
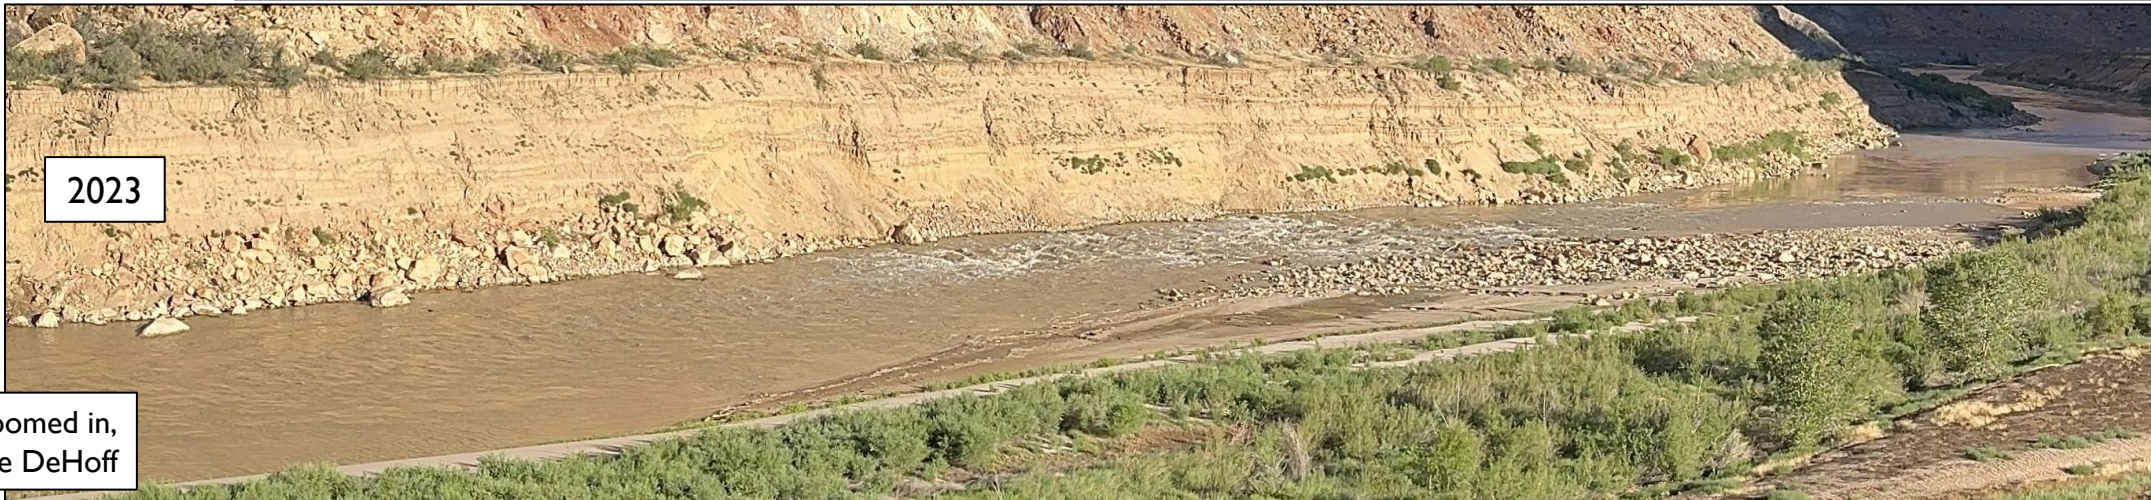
Gypsum Canyon Rapid, zoomed in,
Mike DeHoff

The high water and extended runoff from the winter's snowpack scoured out Gypsum Canyon Rapid.

Five years of repeat photos and ongoing review of pre-reservoir images show that Gypsum Rapid is much closer to being the whole way back.

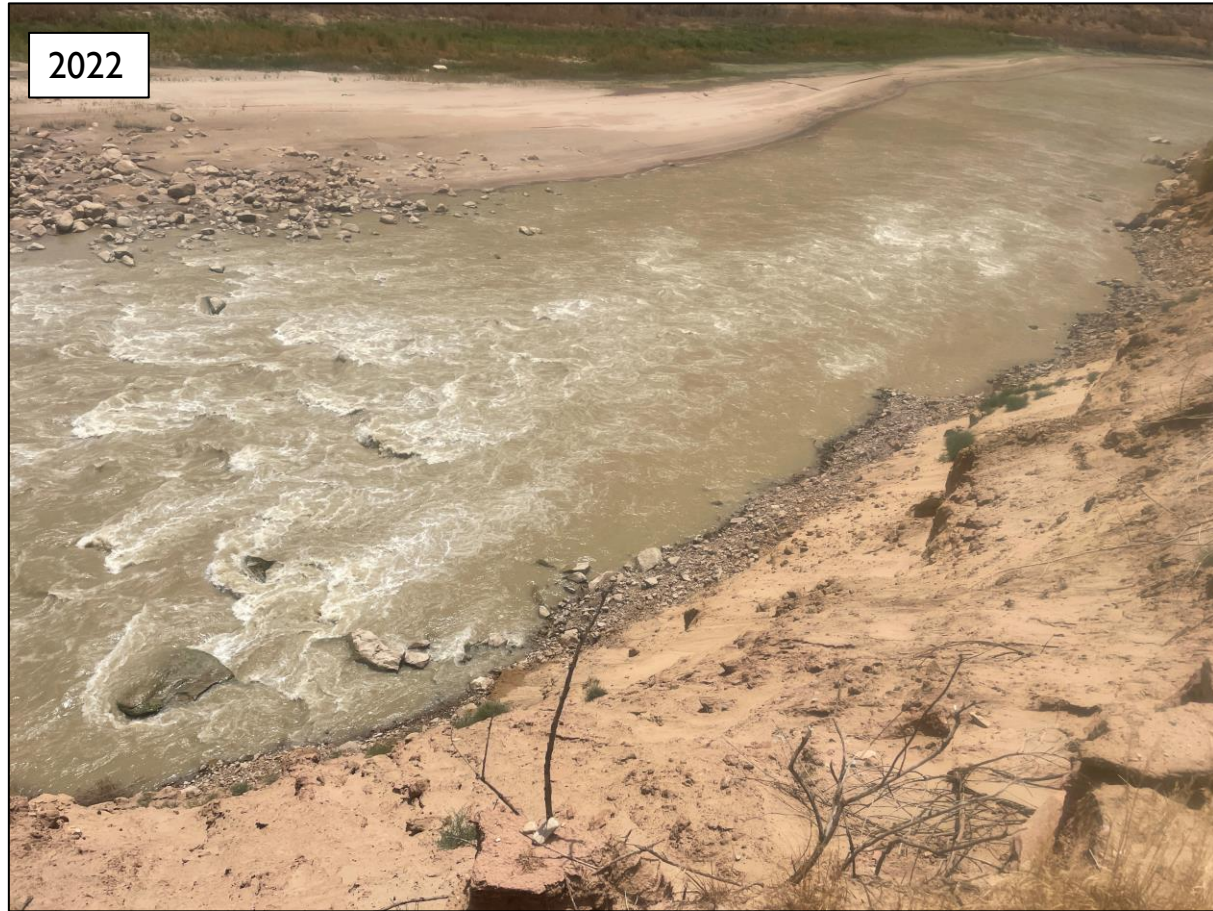
Gypsum Canyon Rapid, 7-23-2022, 4,300 cfs,
Meg Flynn/Mike DeHoff

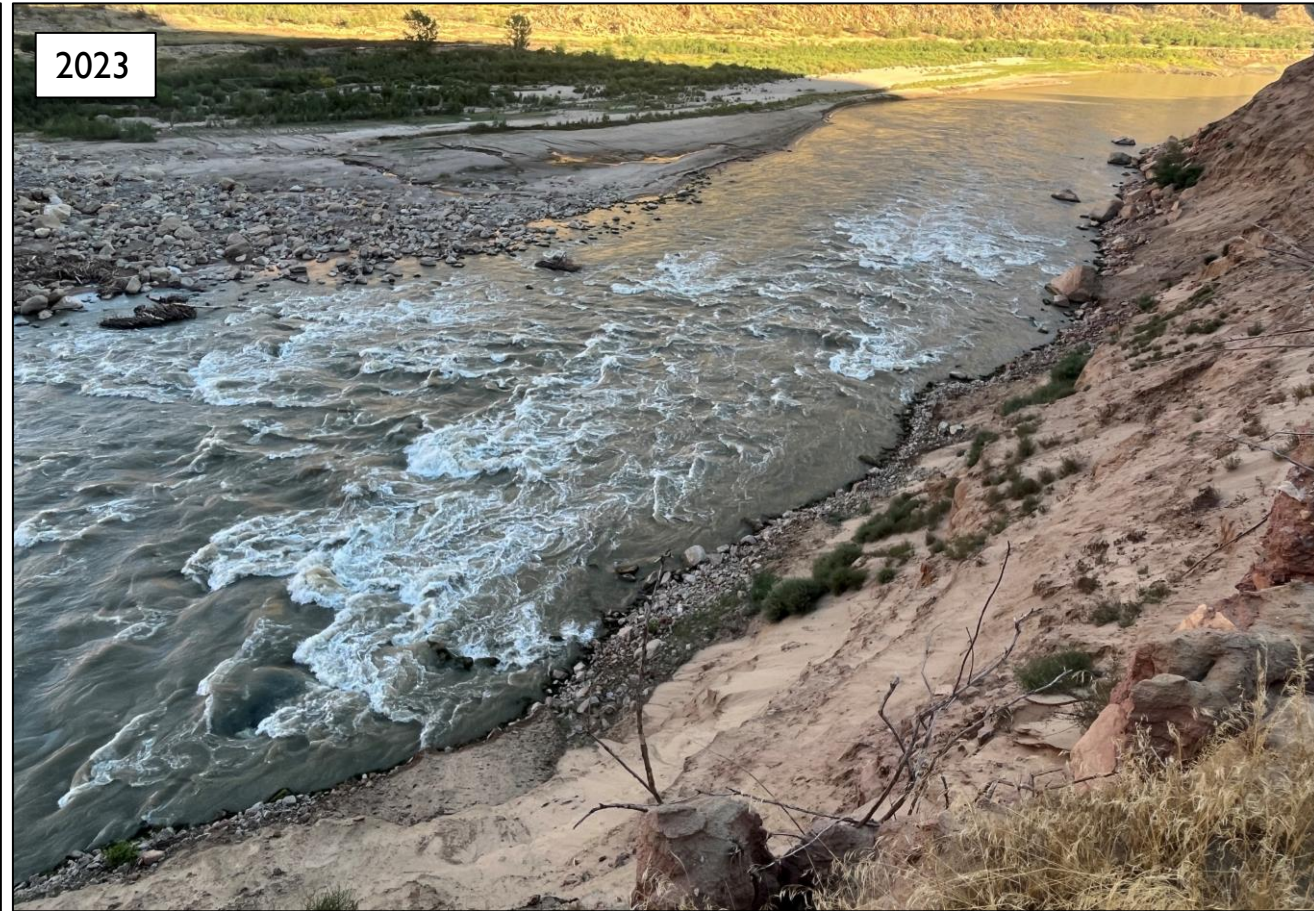
Gypsum Canyon Rapid, 10-9-2023, 6,400 cfs,
Peter Lefebvre

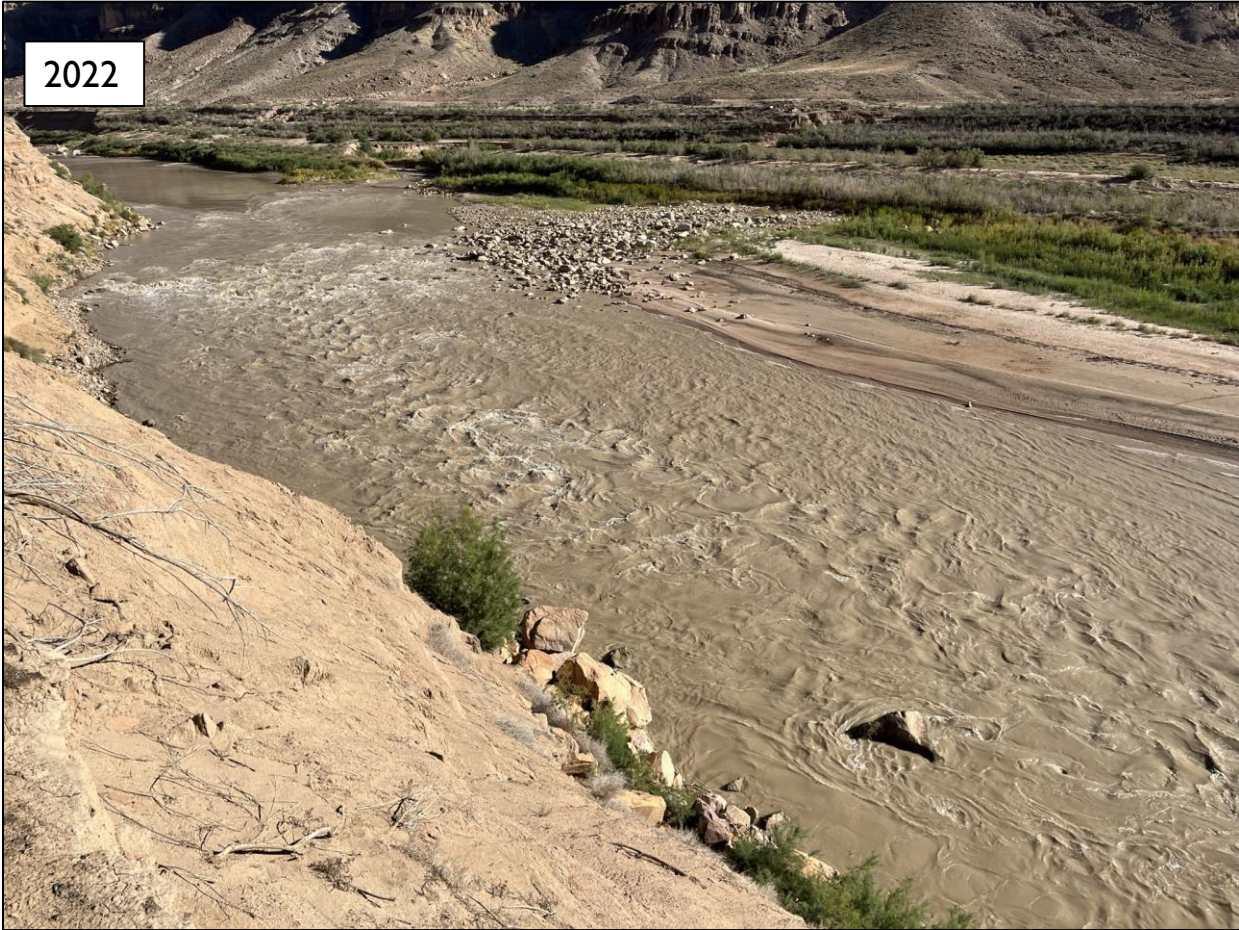
Gypsum Canyon camera view, 10-19-2022, 5,600 cfs, Peter Lefebvre

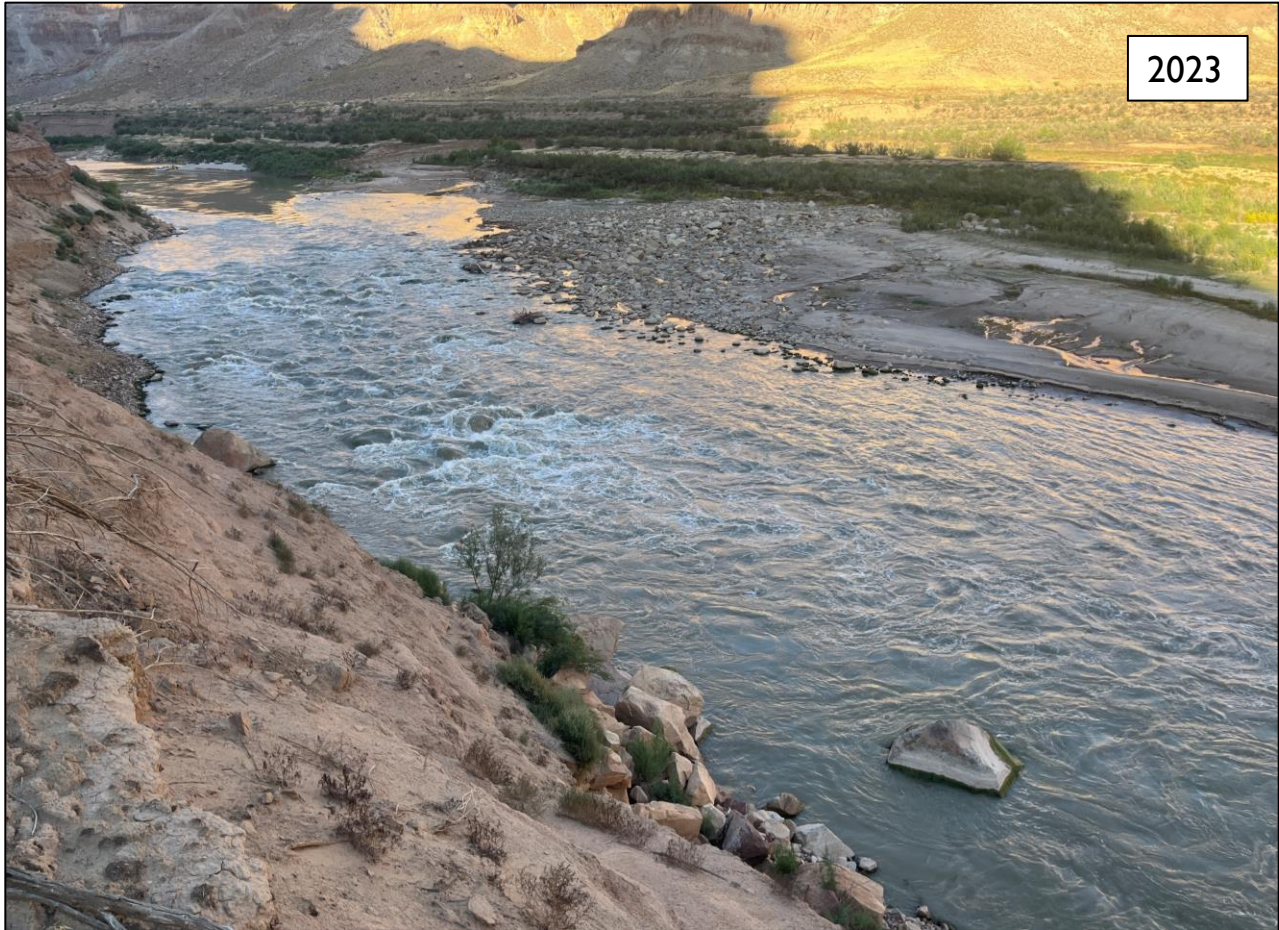
In addition to the new holes near the end of the rapid, note the new boulder on the river right bank that appeared in June/July 2023. Also, Gypsum Canyon's drainage flooded in August 2023 and scoured out the mouth.

Gypsum Canyon camera view, 10-10-2023, 6,400 cfs, Peter Lefebvre

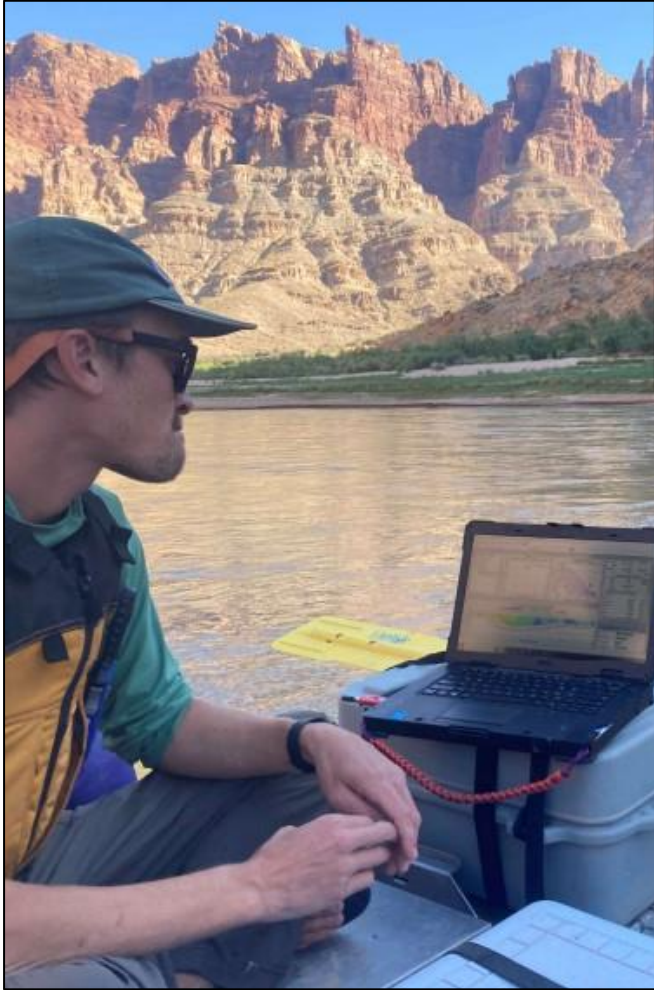
Above chart – collective passes with the ADCP and river cross section, Troy Langworthy

U.S. Geological Survey (USGS) Utah Water Science Center staff have been working on the new gauge just upstream of Gypsum Canyon. This is part of an ongoing effort to calibrate the new gauge. On two of RRP's fall science trips, a discharge reading was taken just below Gypsum Canyon's rapid. This correlates gauge height with an actual cfs flow reading.

Acoustic Doppler Current Profiler (ADCP) work to get a discharge reading. 10-10-2023, Tony Mancuso

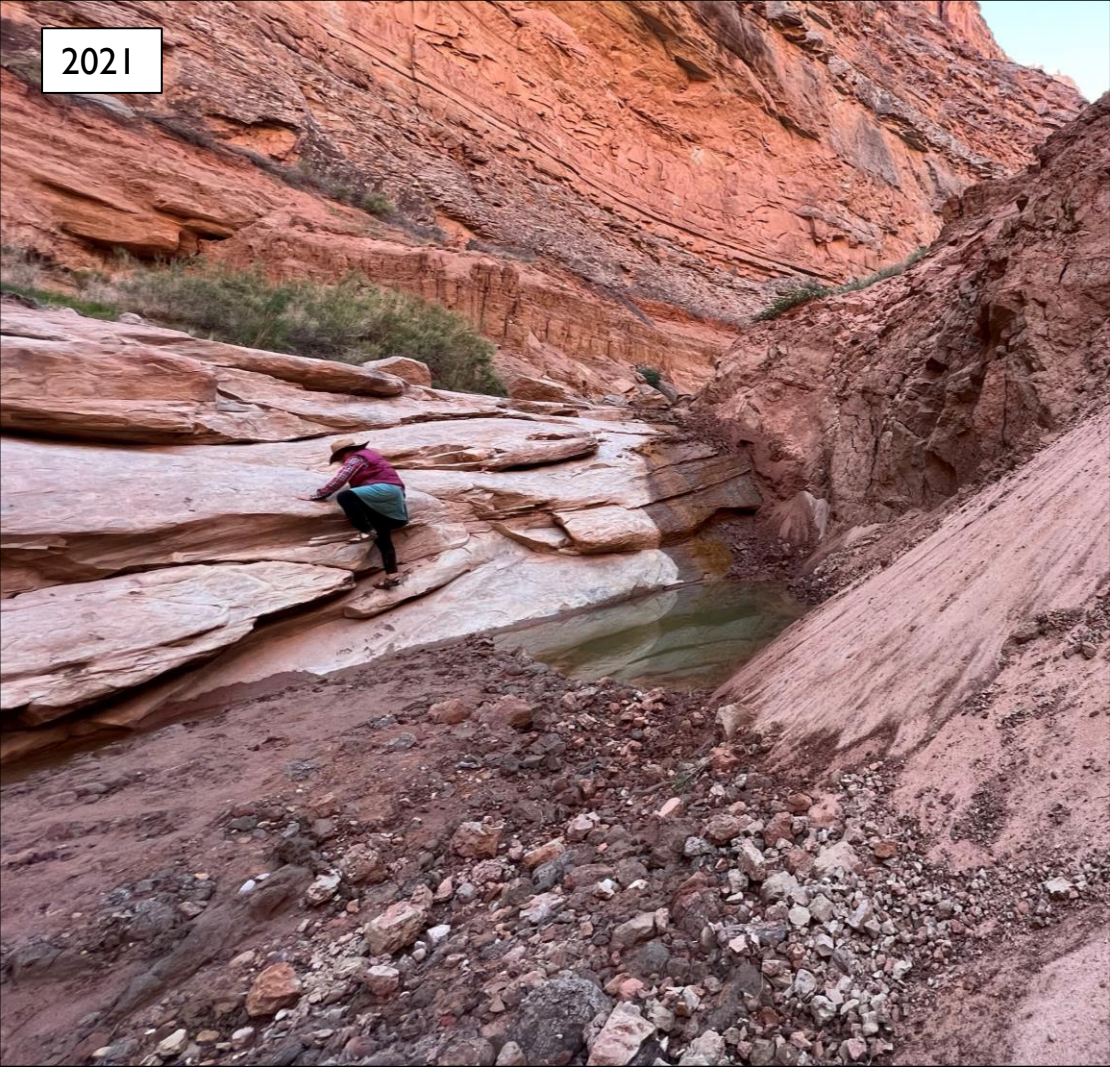
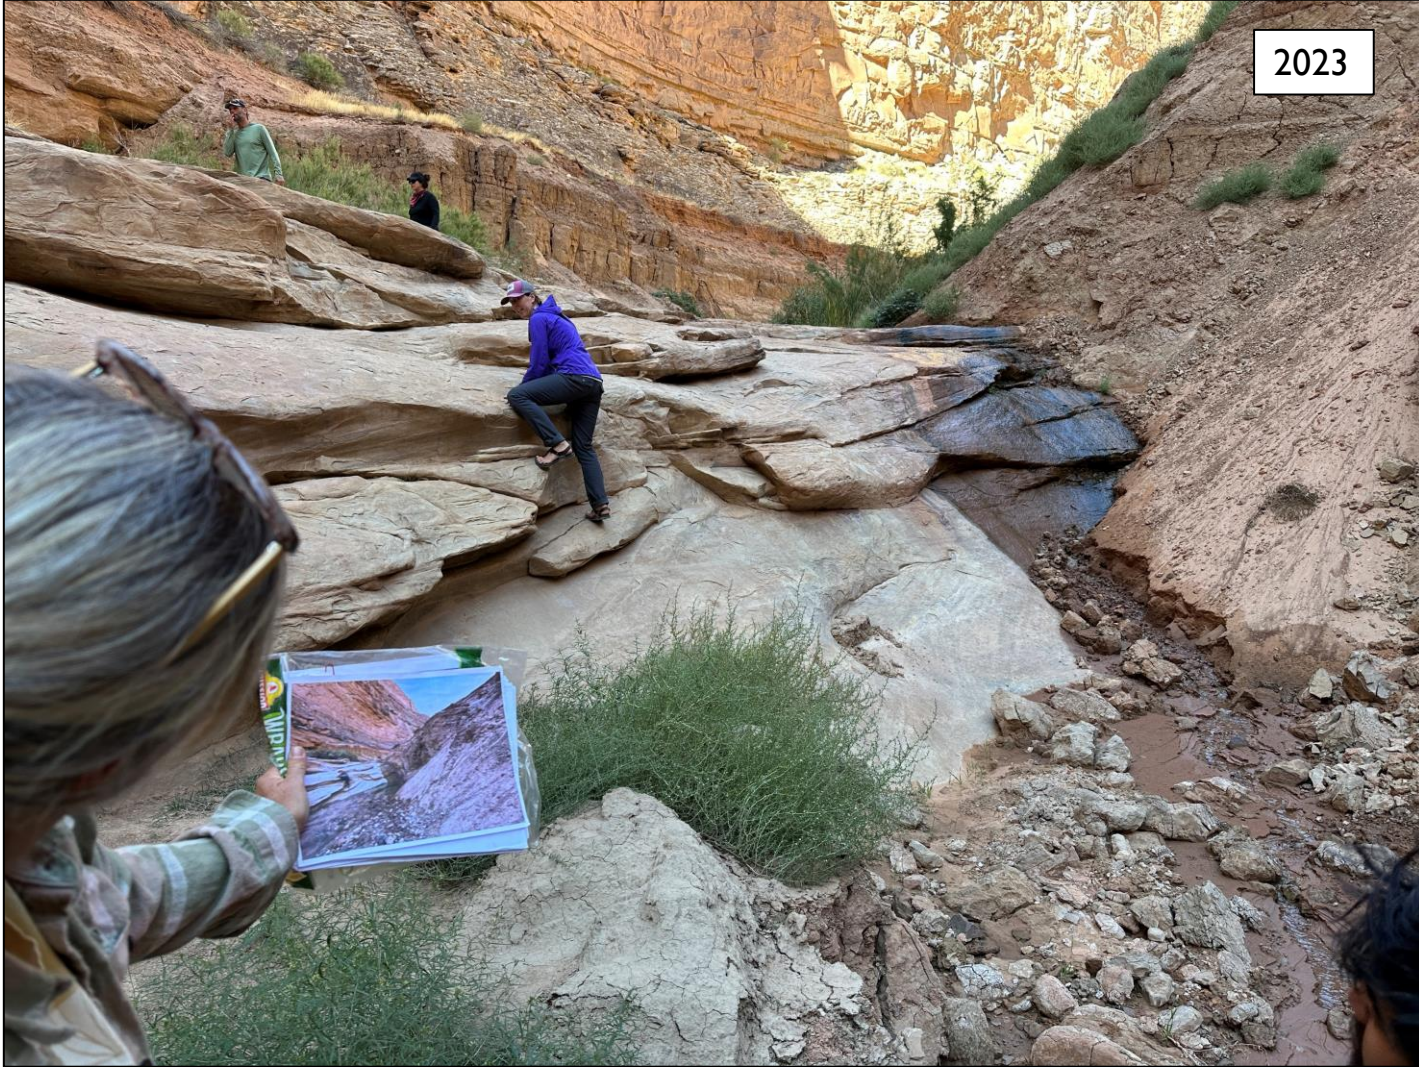
Sasha Reed stepping up the White Jump in Clearwater Canyon. 10-21-2021, Francisco Kjolseth

Note how much further down and into the sediment the wash has cut on looker's right.

The White Jump in Clearwater Canyon. Meg Flynn doing her best "Sasha Reed step up." Coaching by Brenda Bowen. 10-10-2023, Mike DeHoff

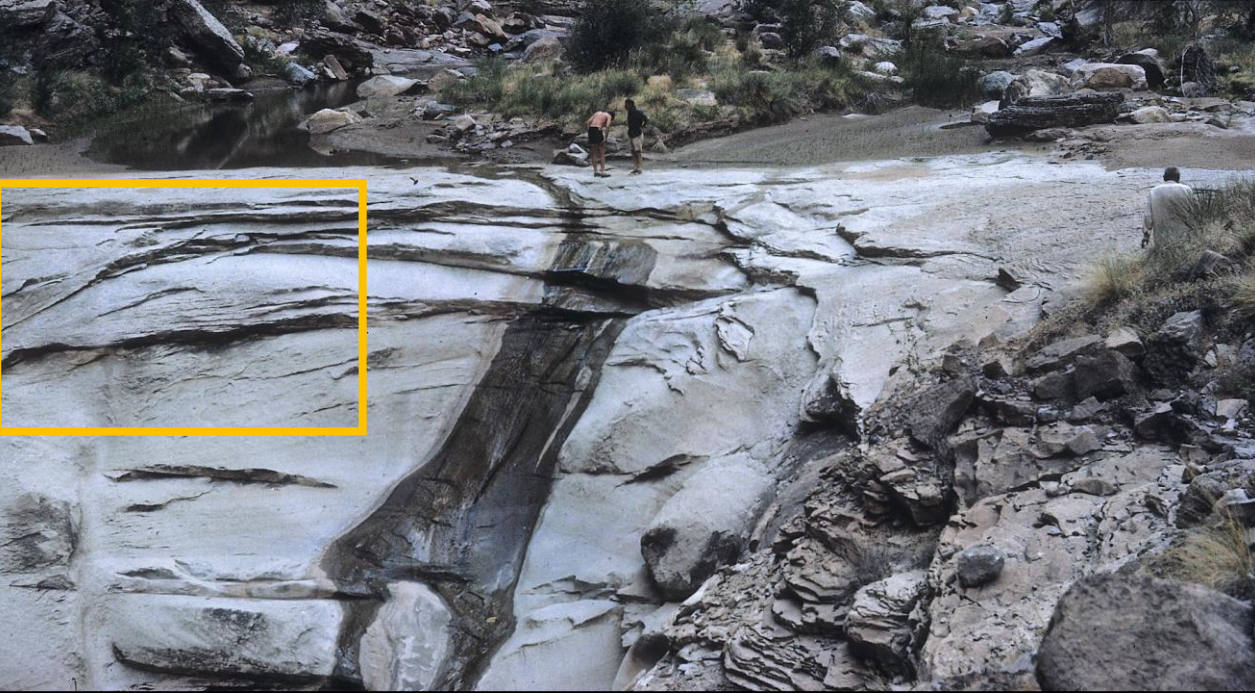
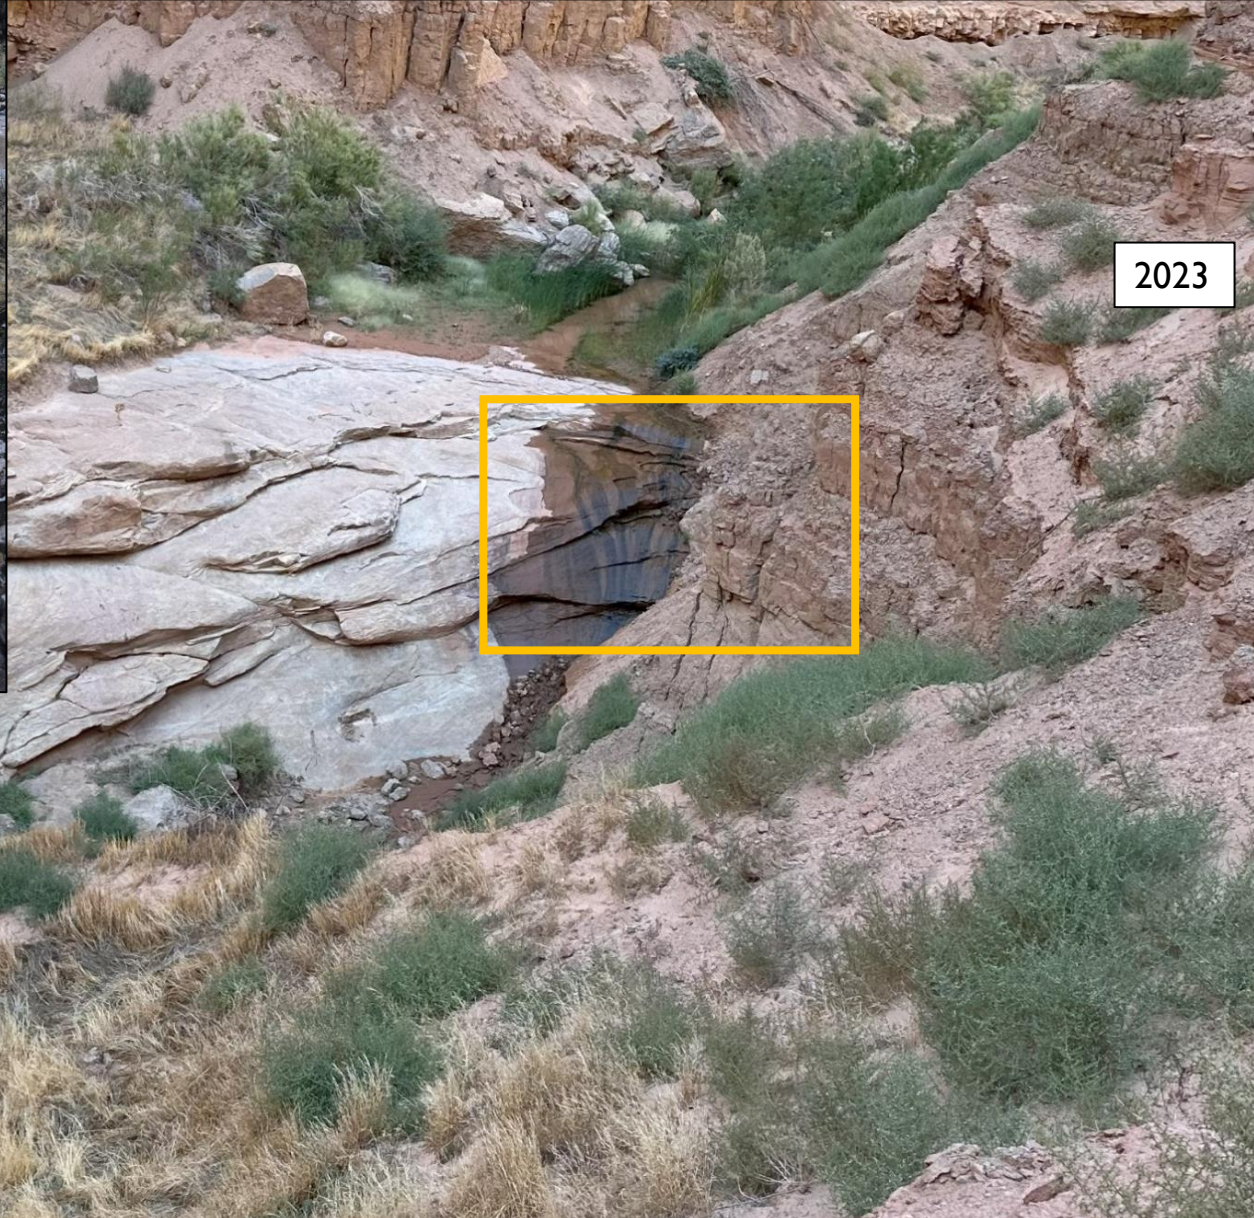
Recognizable features and carving progress

PO789n01_06_014 Clearwater First jump AR Belknap 4_63
1963, Cropped and enhanced,
University of Utah J. Willard Marriot Library

On the sediment looking down on the White Jump,
Clearwater Canyon, 10-10-2023, Meg Flynn

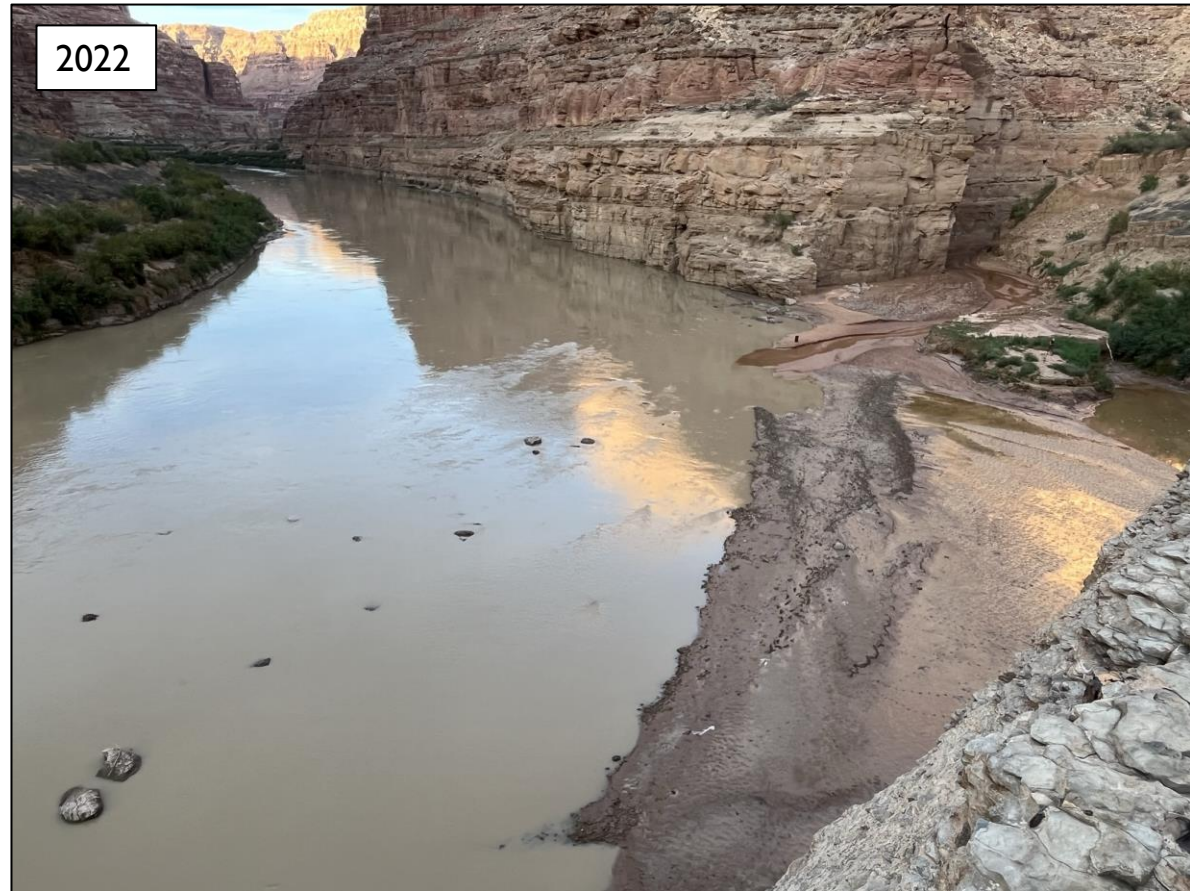
Dark Canyon Mouth, Point I mouth horizontal,
5,600 cfs, bridge gauge 3,581 feet, 10-19-2022, Peter Lefebvre

Note the various-sized debris in the alluvial fan that was from a heavy monsoon cycle.

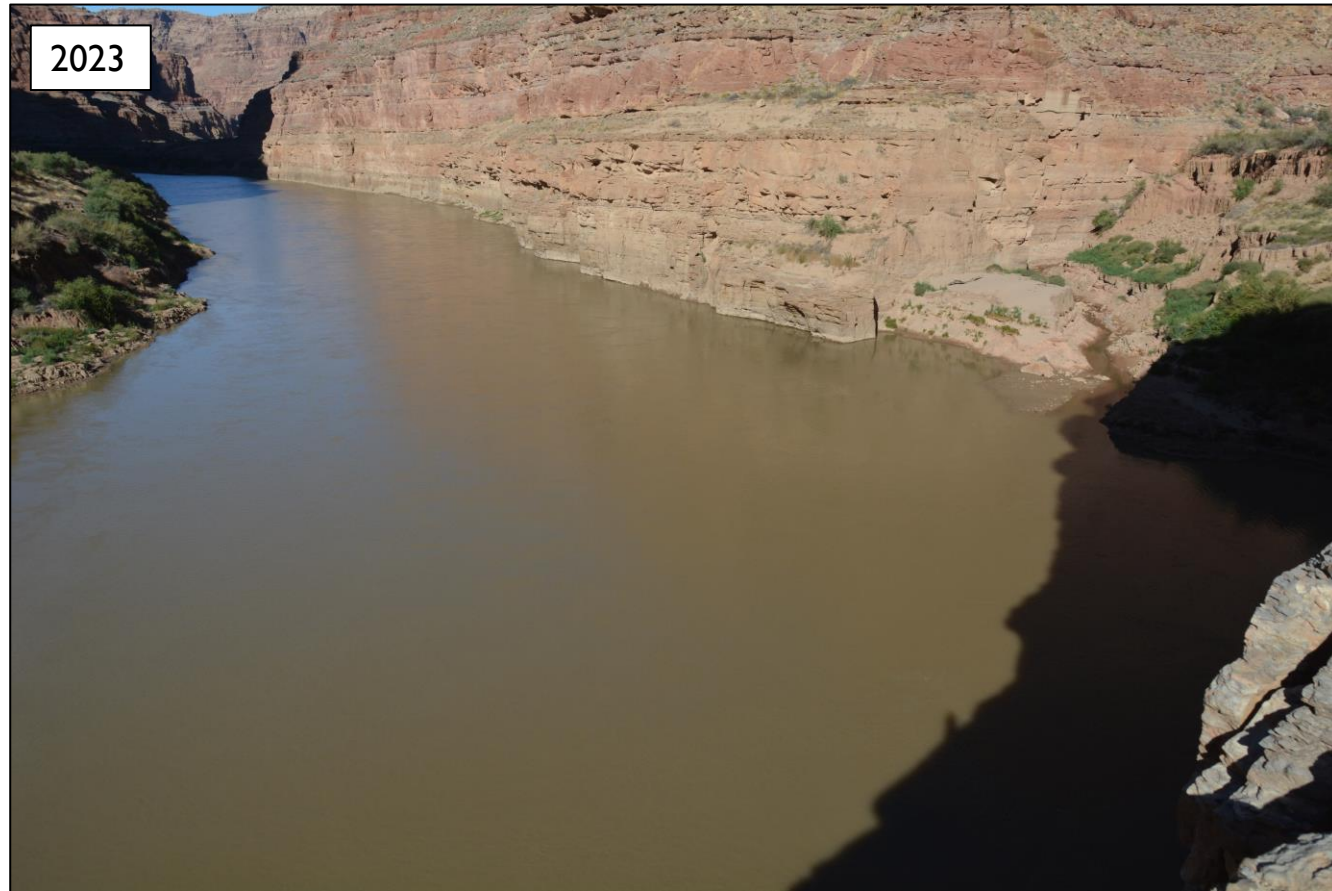
Dark Canyon Mouth, Point I mouth horizontal,
6,400 cfs, bridge gauge 3,577 feet, 10-10-2023, Peter Lefebvre

The eddy in the shade was up to 45 feet deep. All the outflow debris from the 2022 monsoon cycle was scoured away by the 2023 runoff.

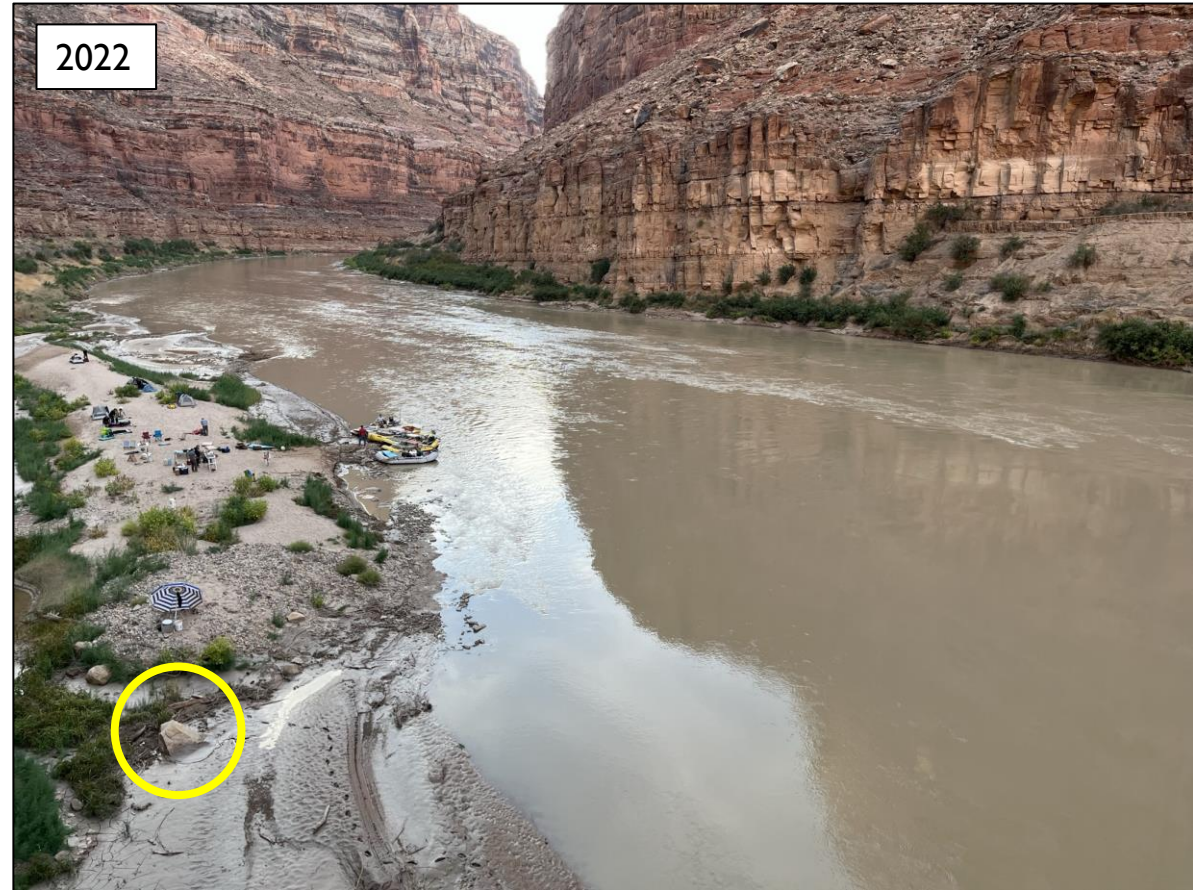
Downstream from Dark Canyon, Point 2, 5,600 cfs, bridge gauge 3,581 feet, 10-19-2022, Peter Lefebvre

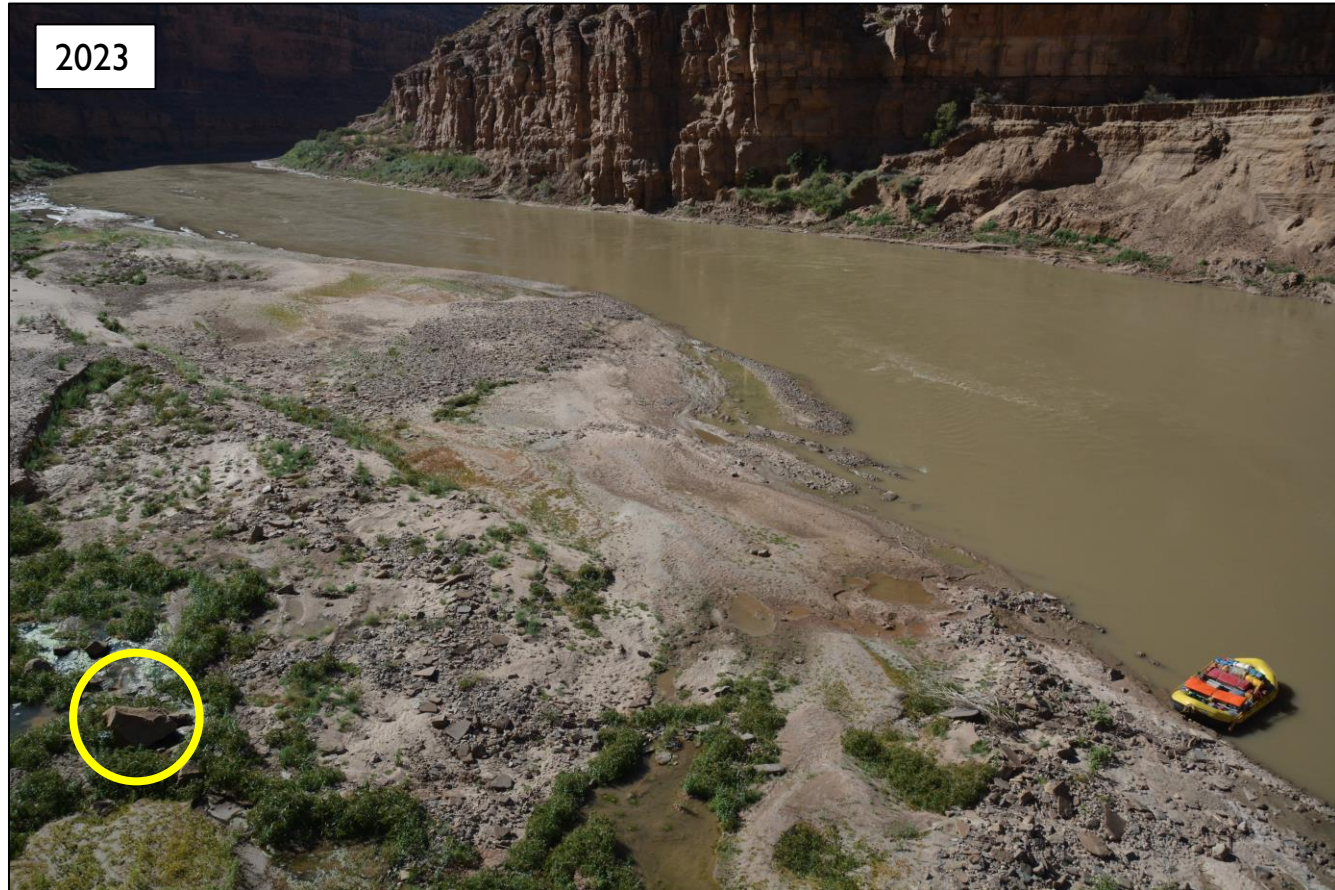
Downstream from Dark Canyon, Point 2, 6,400 cfs, bridge gauge 3,577 feet, 10-10-2023, Peter Lefebvre

The river is lower in its bed at the bridge gauge. It also appears to be lower in the 2023 photo; more cobble bar is showing, but there is also 1,000 cfs more water in the river.

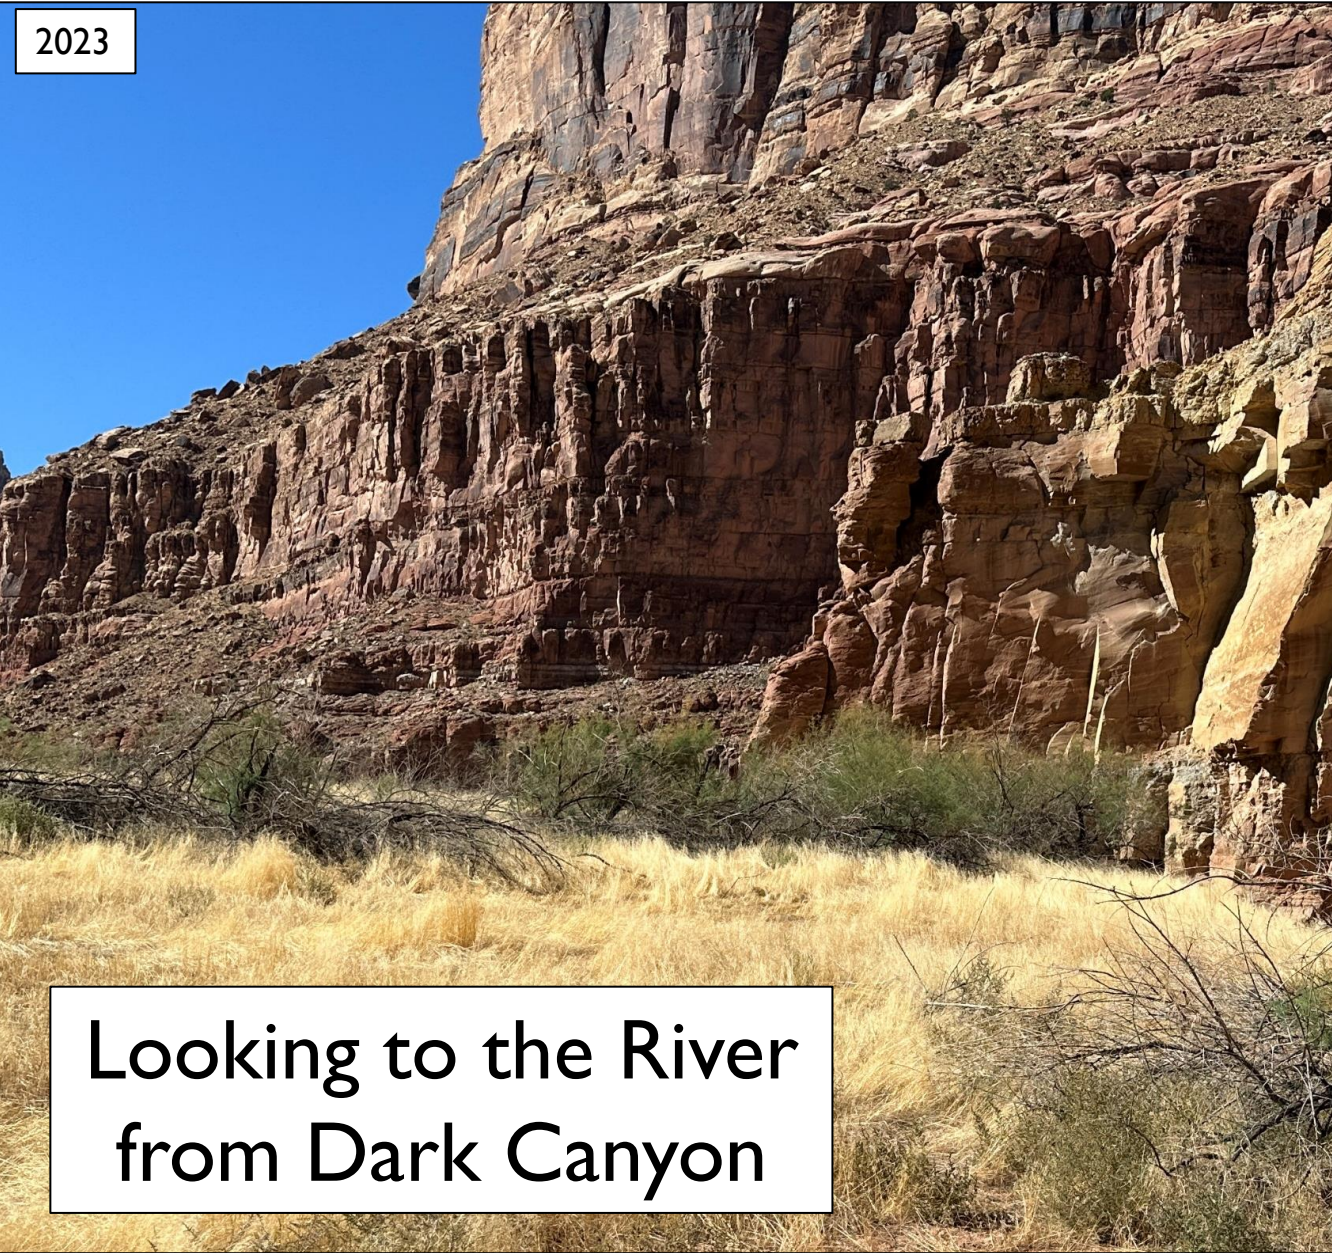
Photo match attempt of Goldman Frost Mouth of Dark Canyon photo, 10-10-2023, Mike DeHoff
The skyline could only be seen from on top of the Dominy bench approximately 150–200 feet higher than the 1950s photo location. This is also roughly 100 feet higher than the current wash mouth elevation.
