Returning Rapids

Fall Trip Findings

September and October 2023

2023 was a very dynamic year for Cataract Canyon. In September and October, the Returning Rapids Project (RRP) completed three Cataract Canyon research trips and one North Wash-based survey effort. This year, RRP has continued to monitor changes, build a data set, and communicate the story of what we are observing along this section of the Colorado River.

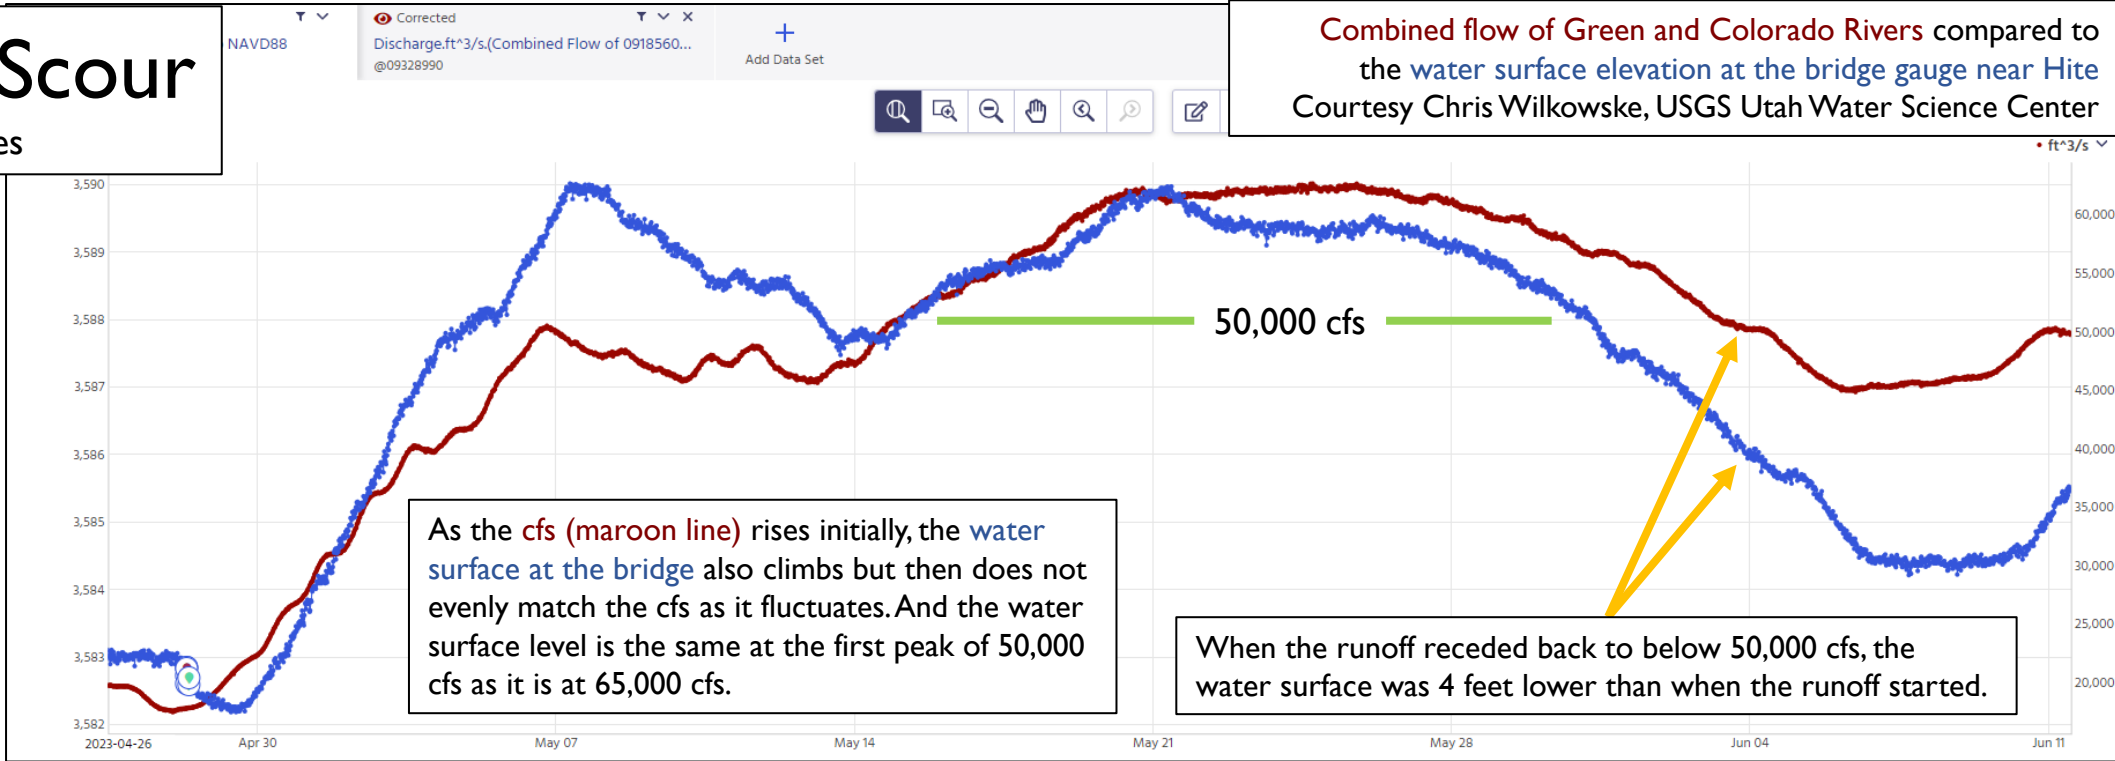
Comparing the **cfs flow** through Cataract Canyon with the **water surface elevation at the bridge gauge near Hite** you can see the river downcutting through the river bed.

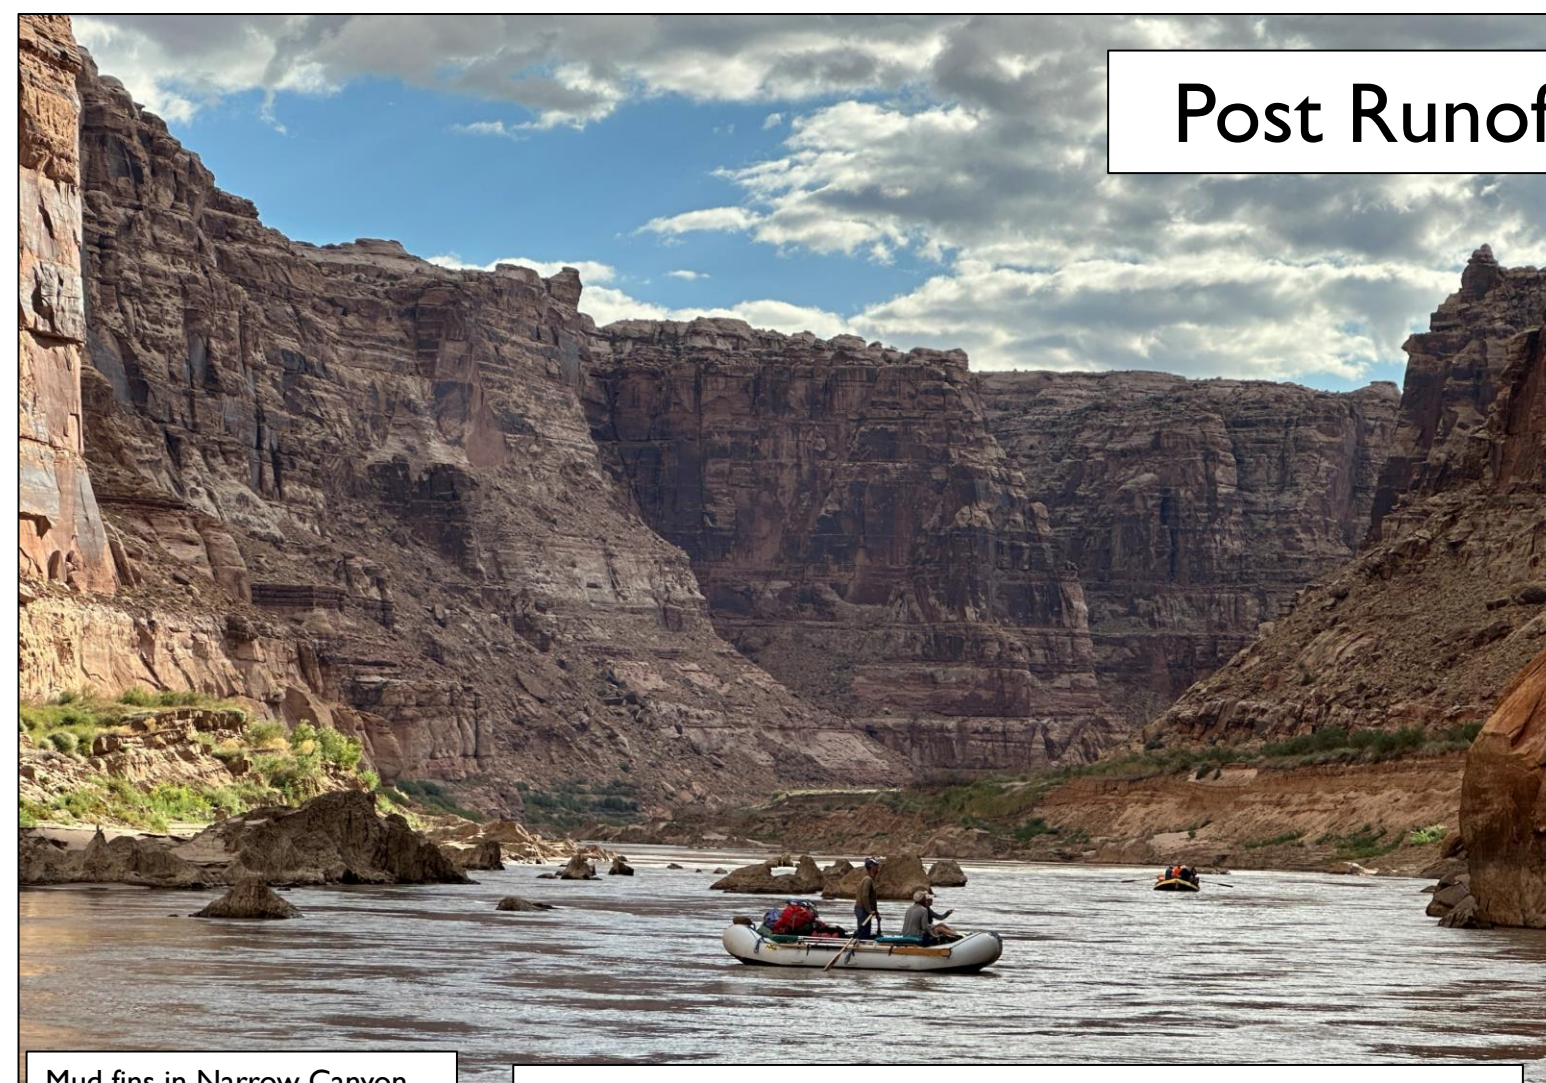
Mud fins in Narrow Canyon
10-11-2023, Mike DeHoff

As the high water receded over the summer, it became apparent that any fine sediment that could be swept further downstream by the river was carried off. The durable clay layers were left, and they emerged like sea monsters in the river channel.

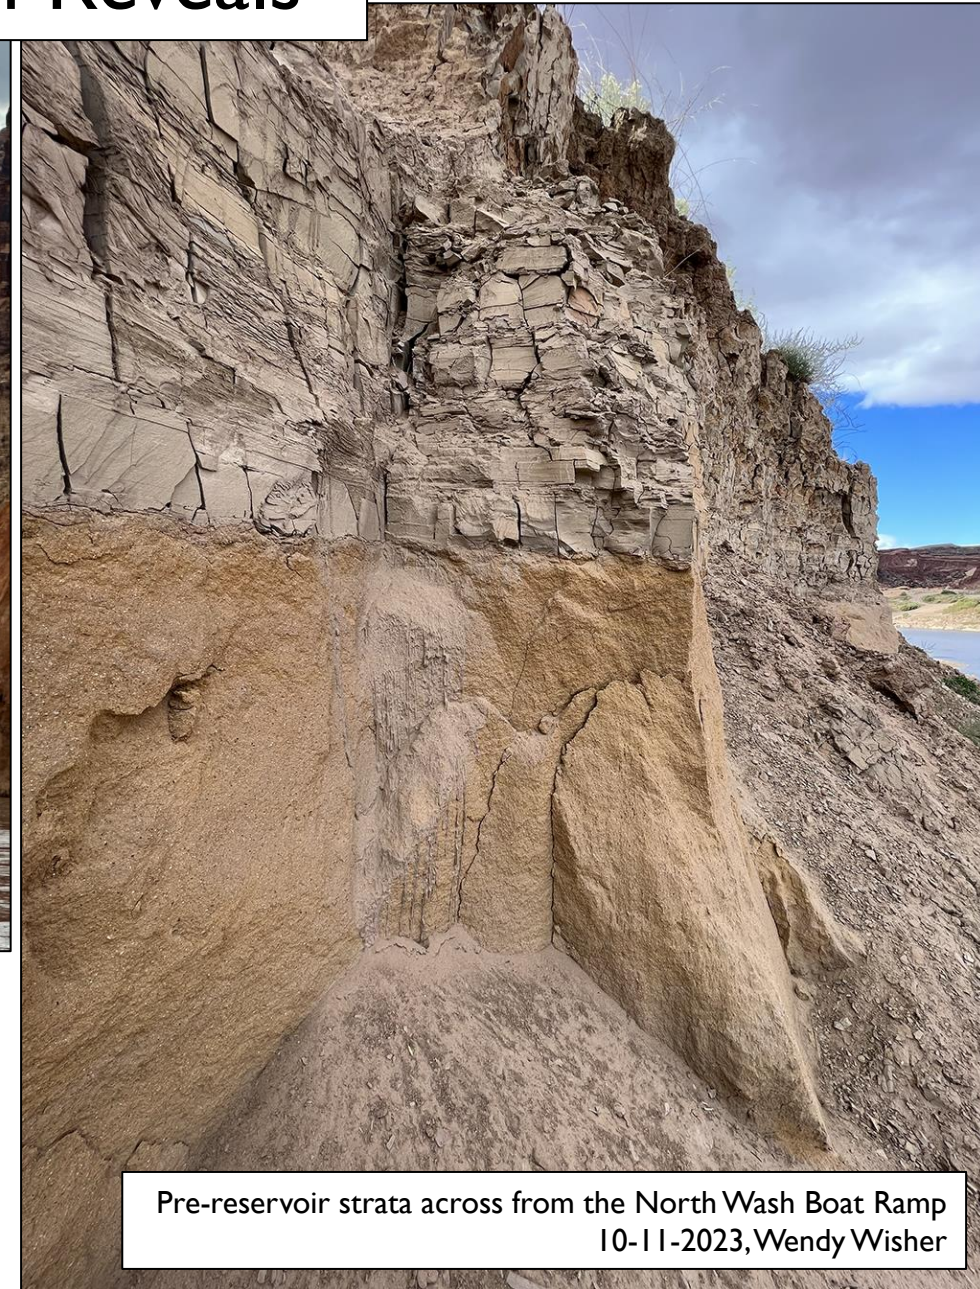
Pre-reservoir strata across from the North Wash Boat Ramp
10-11-2023, Wendy Wisher

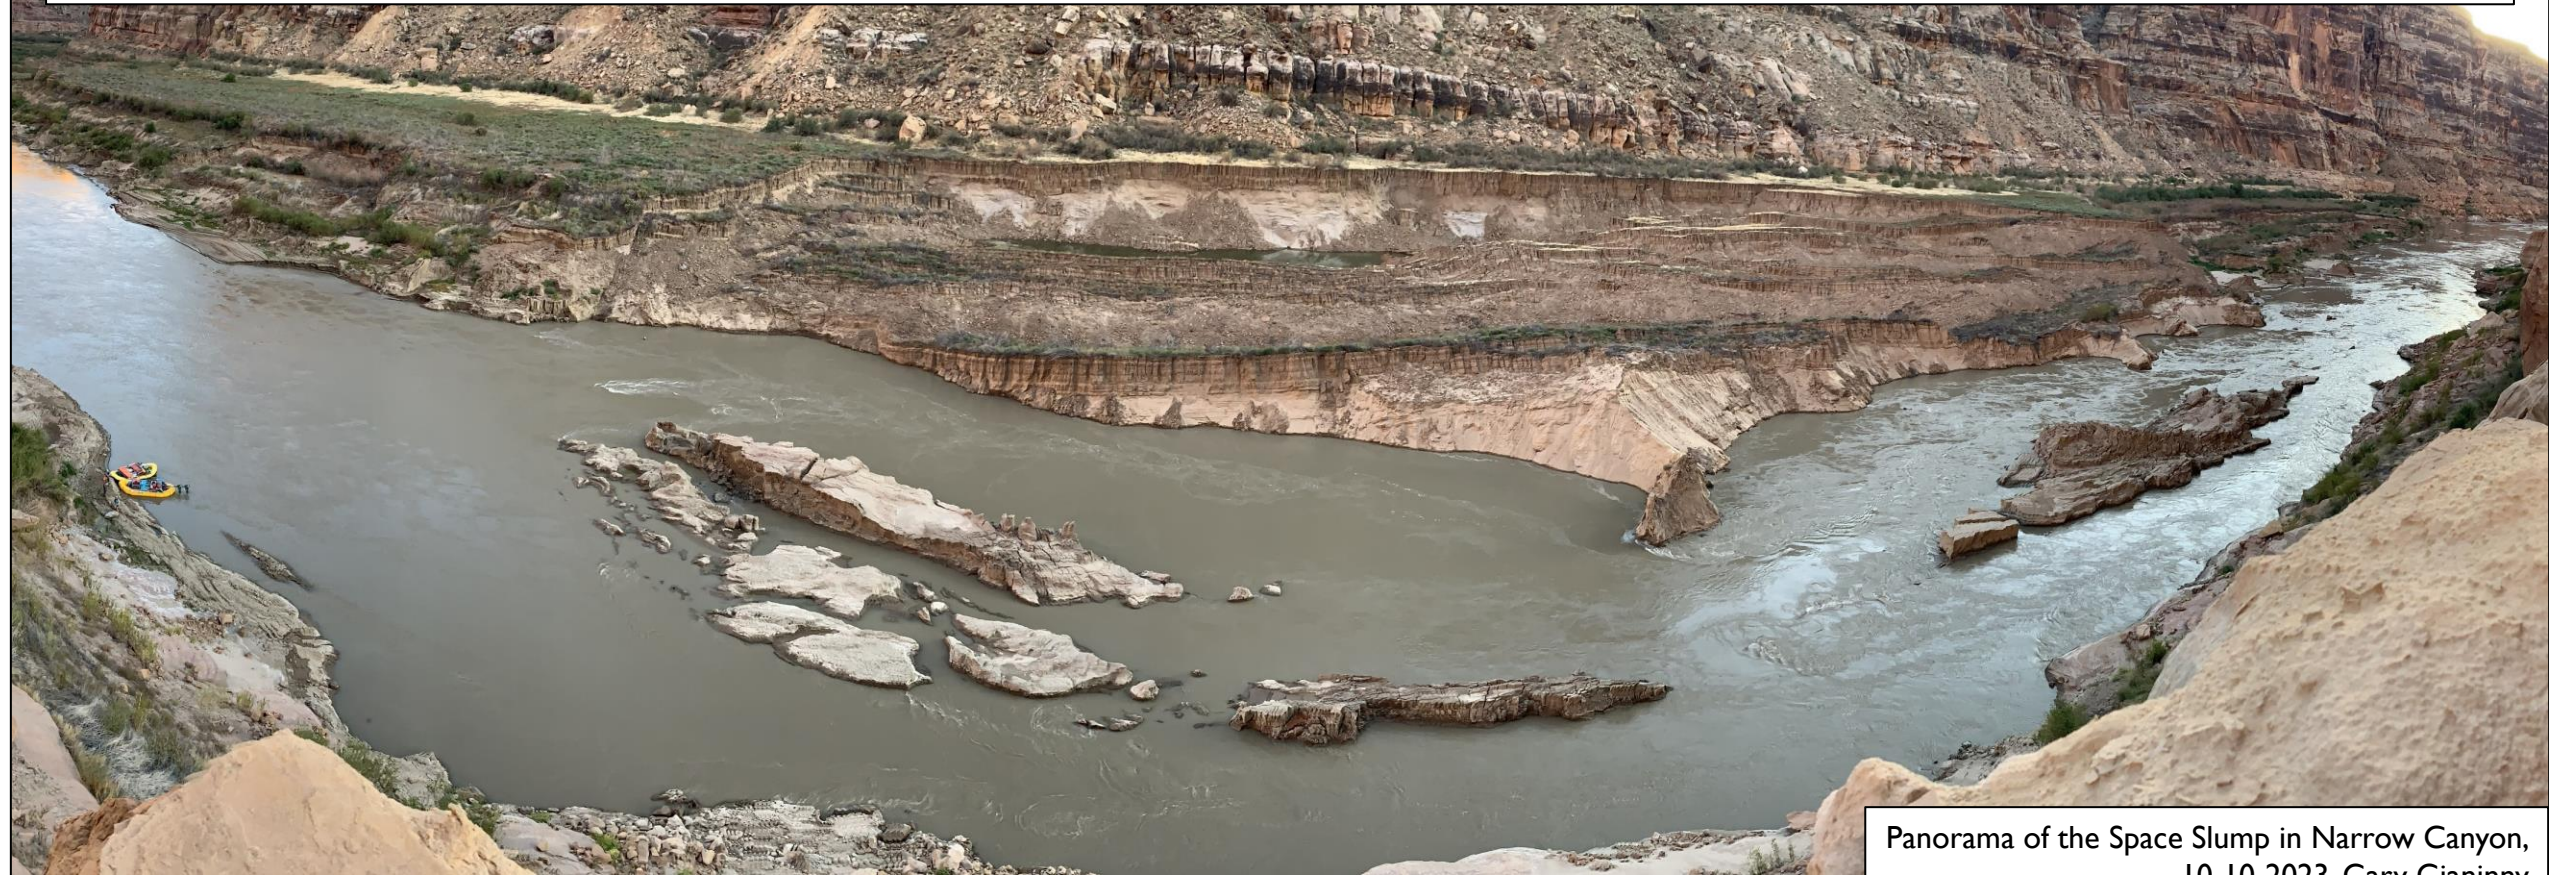
Between July 12 and 13, 2023, near river mile 174 in the upper end of Narrow Canyon, there was a large slump that laterally moved from river left into the river. It pushed the Colorado over into the river right bank.

Initial reports stated that it wasn't there in the morning and then appeared in the afternoon. The reporting party noted that there was mud and debris high above the waterline on the river right side of the river. The river was compressed into a single tight channel and heavily laden with sediment.

Panorama of the Space Slump in Narrow Canyon,
10-10-2023, Gary Gianinny

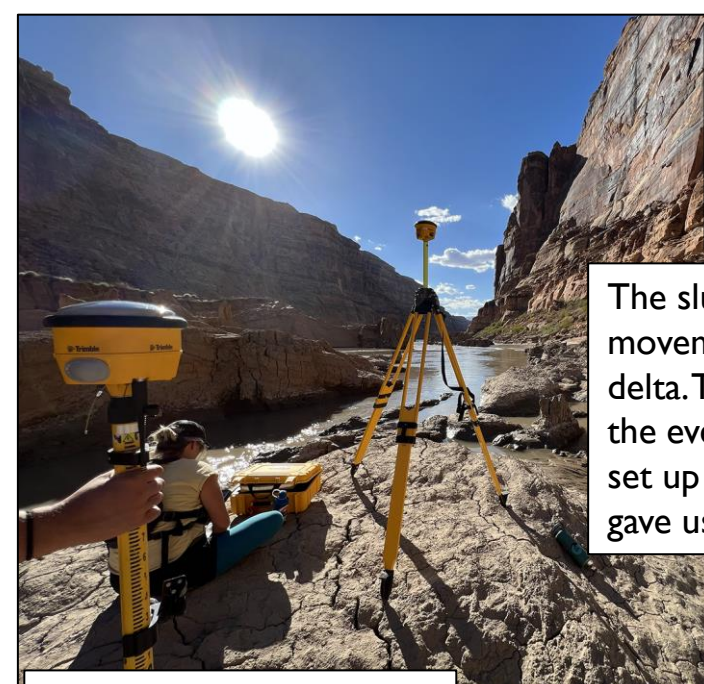
The slump was one of the largest observed single movements of sediment on the Colorado sediment delta. To understand how much sediment moved in the event, an RTK (high tech survey instrument) was set up and the slump's perimeter was surveyed. This gave us an overall sediment volume.

RTK set up on Clay Island
10-10-2023, Wendy Wischer

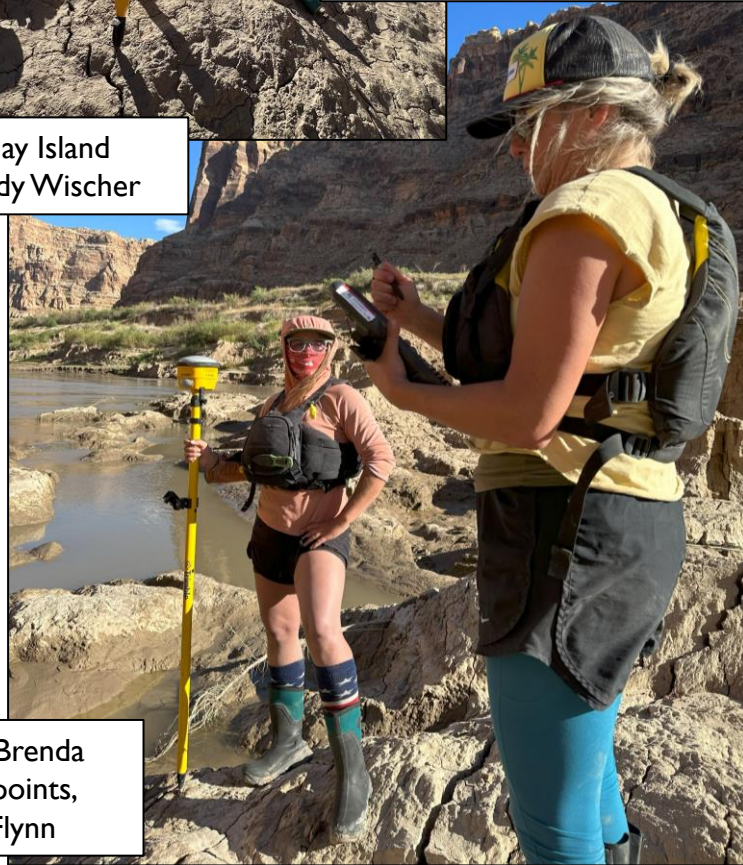
Kestrel Kunz and Brenda Bowen surveying points,
10-10-2023, Meg Flynn

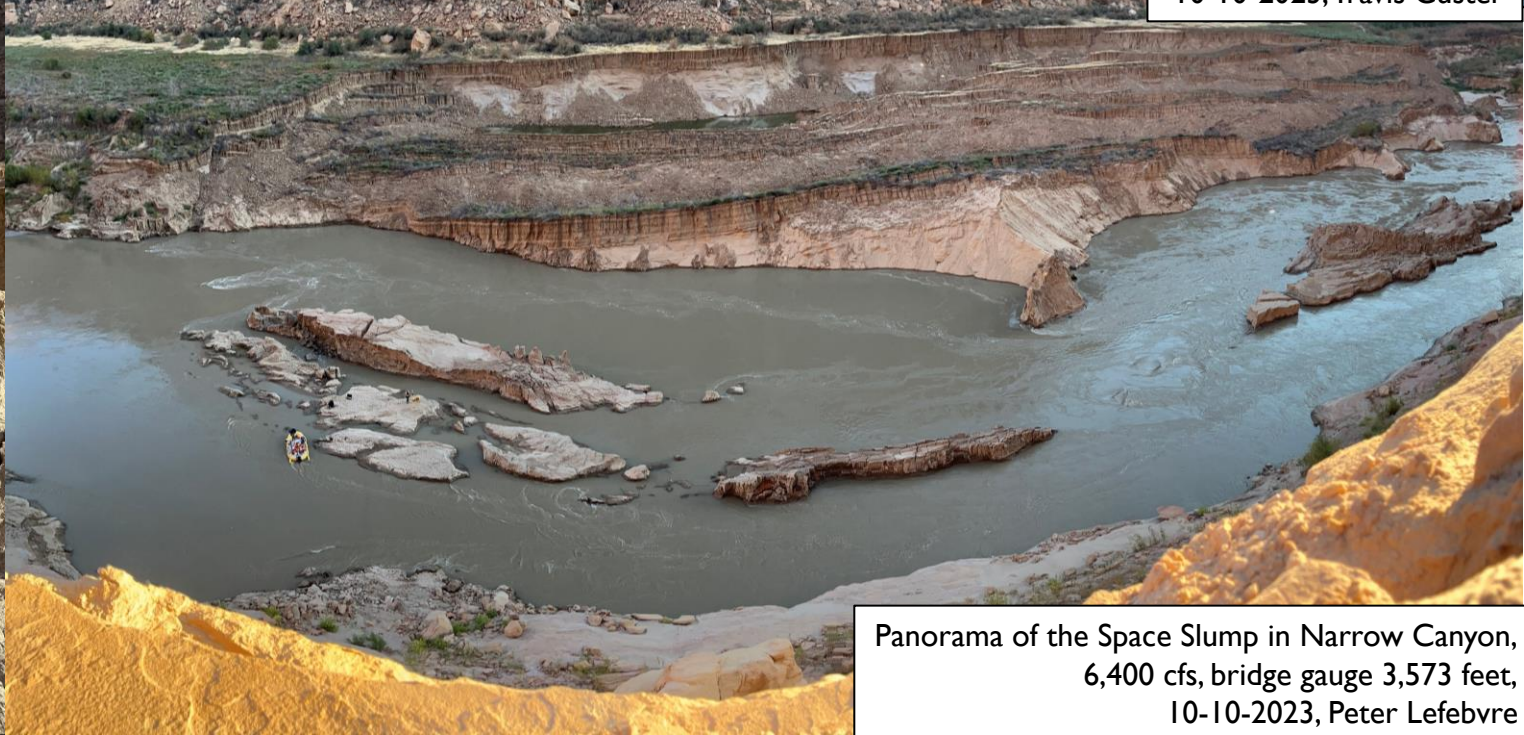
On the September and October trips we observed that the slump area was changing on a weekly basis.

Durable clay fins would collapse and obstacles in the channels were different on each run through the slump area.

Panorama of the Space Slump in Narrow Canyon,
6,400 cfs, bridge gauge 3,573 feet,
10-10-2023, Peter Lefebvre

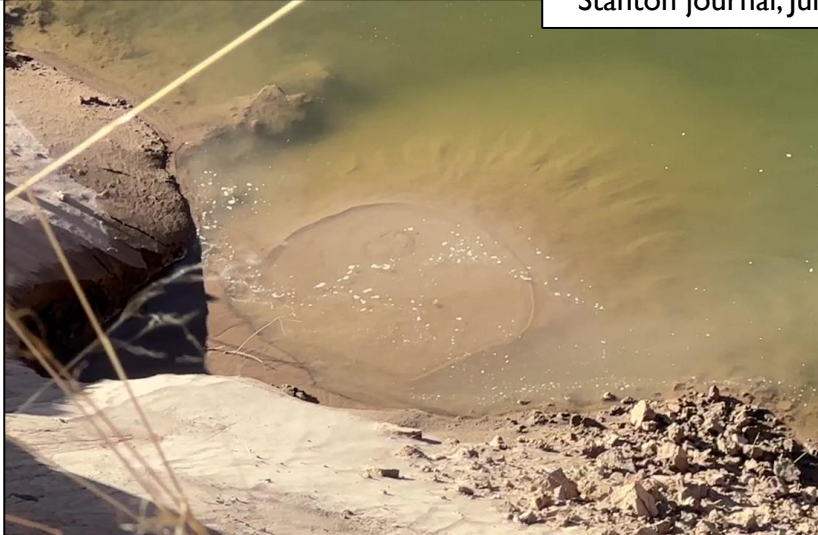
On the river right side of upper Narrow Canyon, there are several sulphur springs that have been carved-out of the sediment. They are mentioned in pre-reservoir surveys and can be seen in historic photos. Historic documents also mention a warm spring on the left bank. When participants from the 2023 fall trip climbed onto the sediment terrace of the slump, they found a hanging pond with a spring bubbling up.

It is likely this spring lubricated the slump.

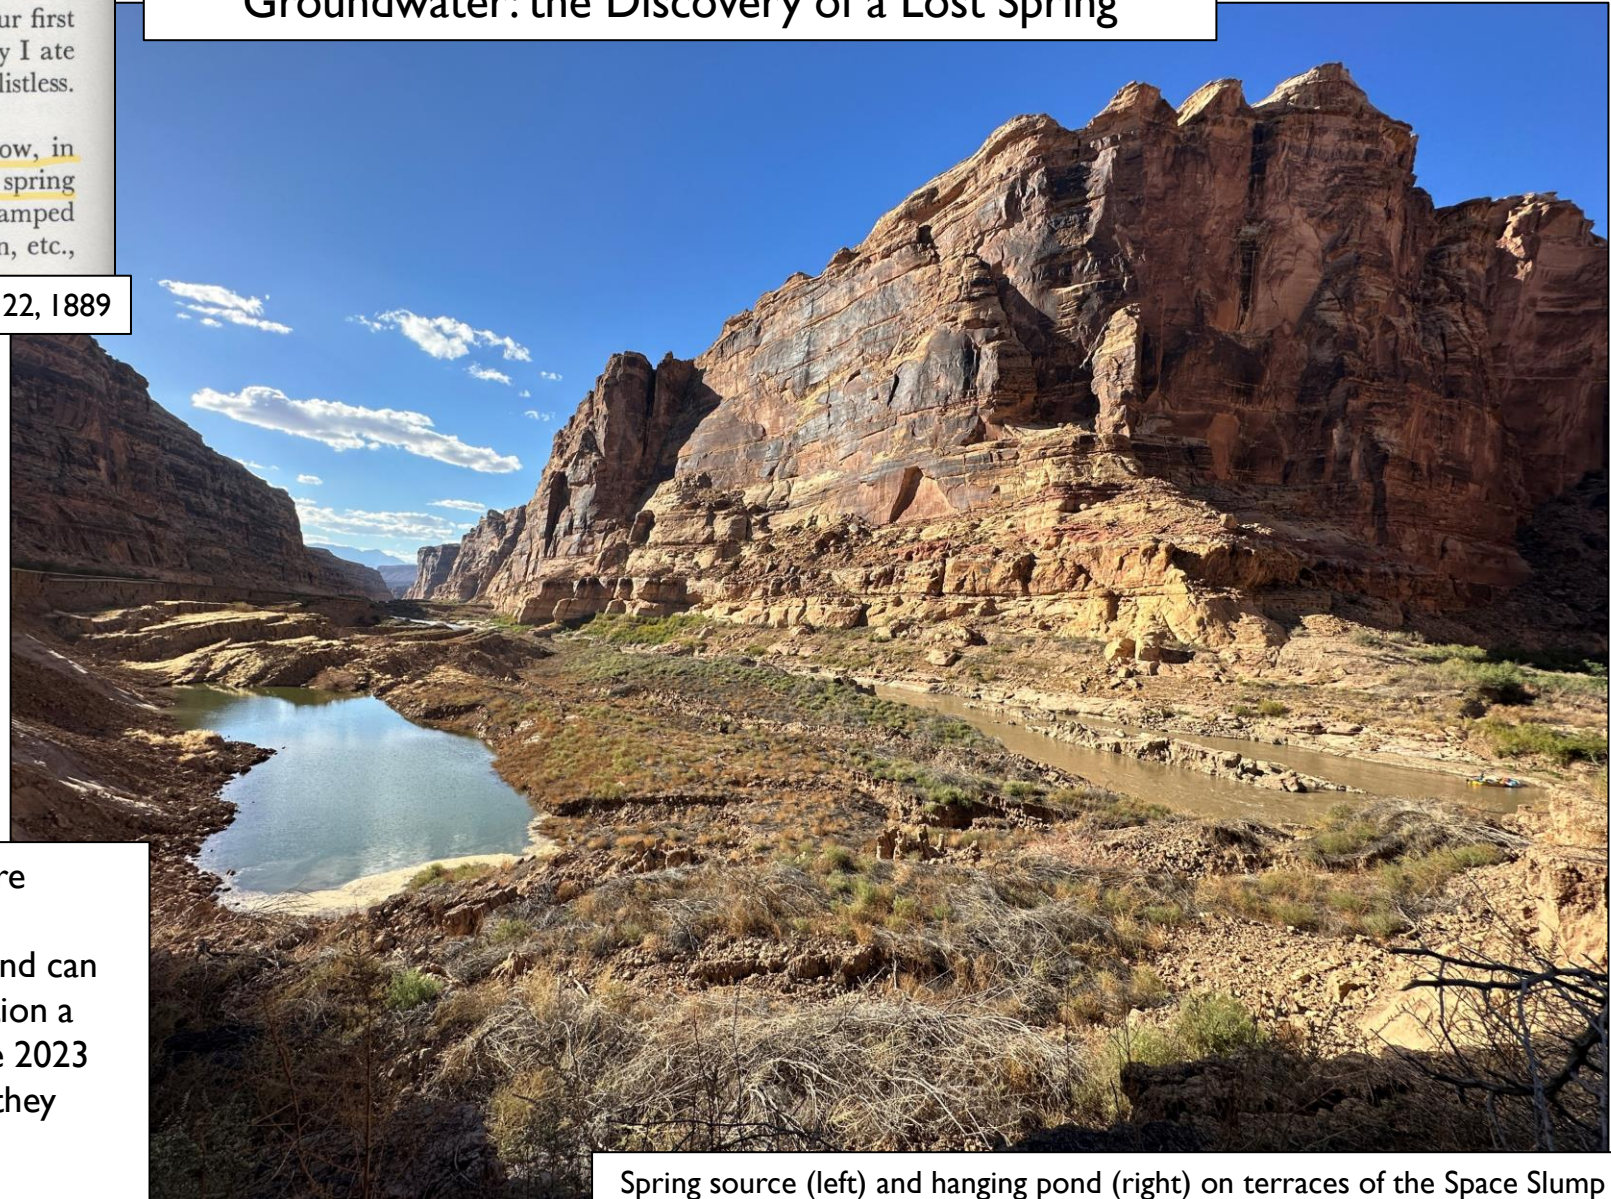
Spring source (left) and hanging pond (right) on terraces of the Space Slump
10-10-2023, Davide Ippolito

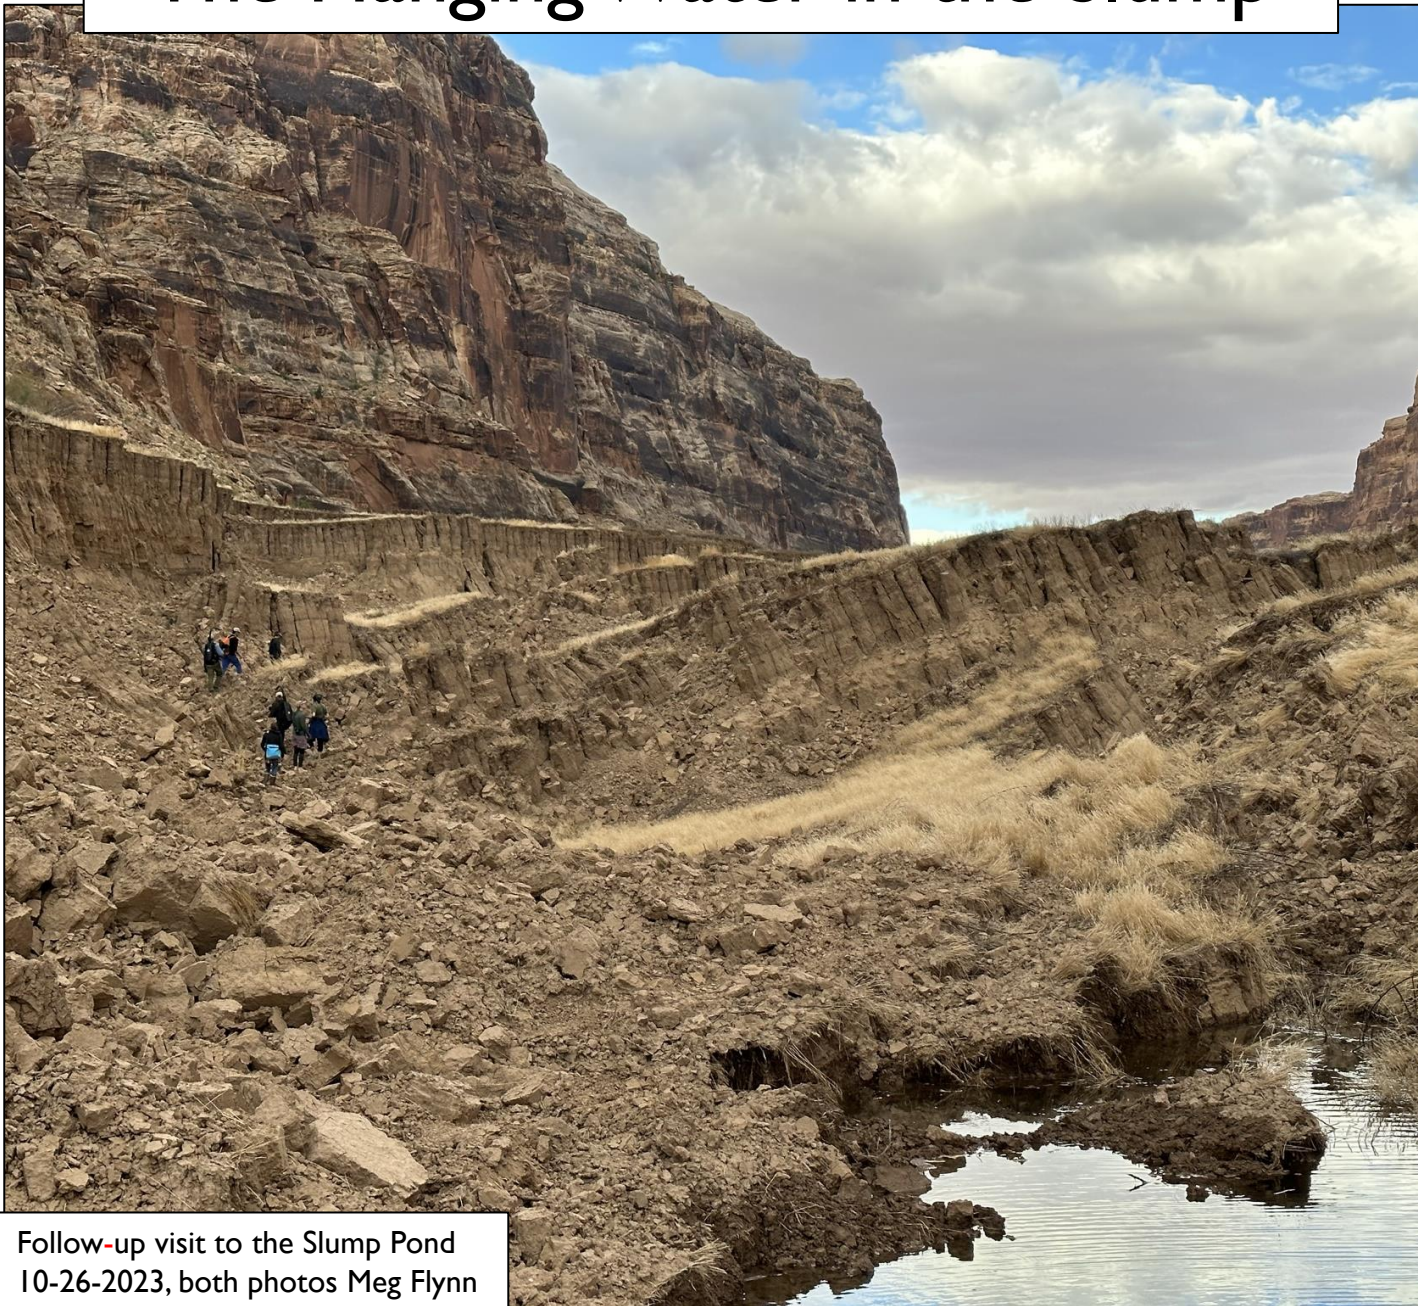
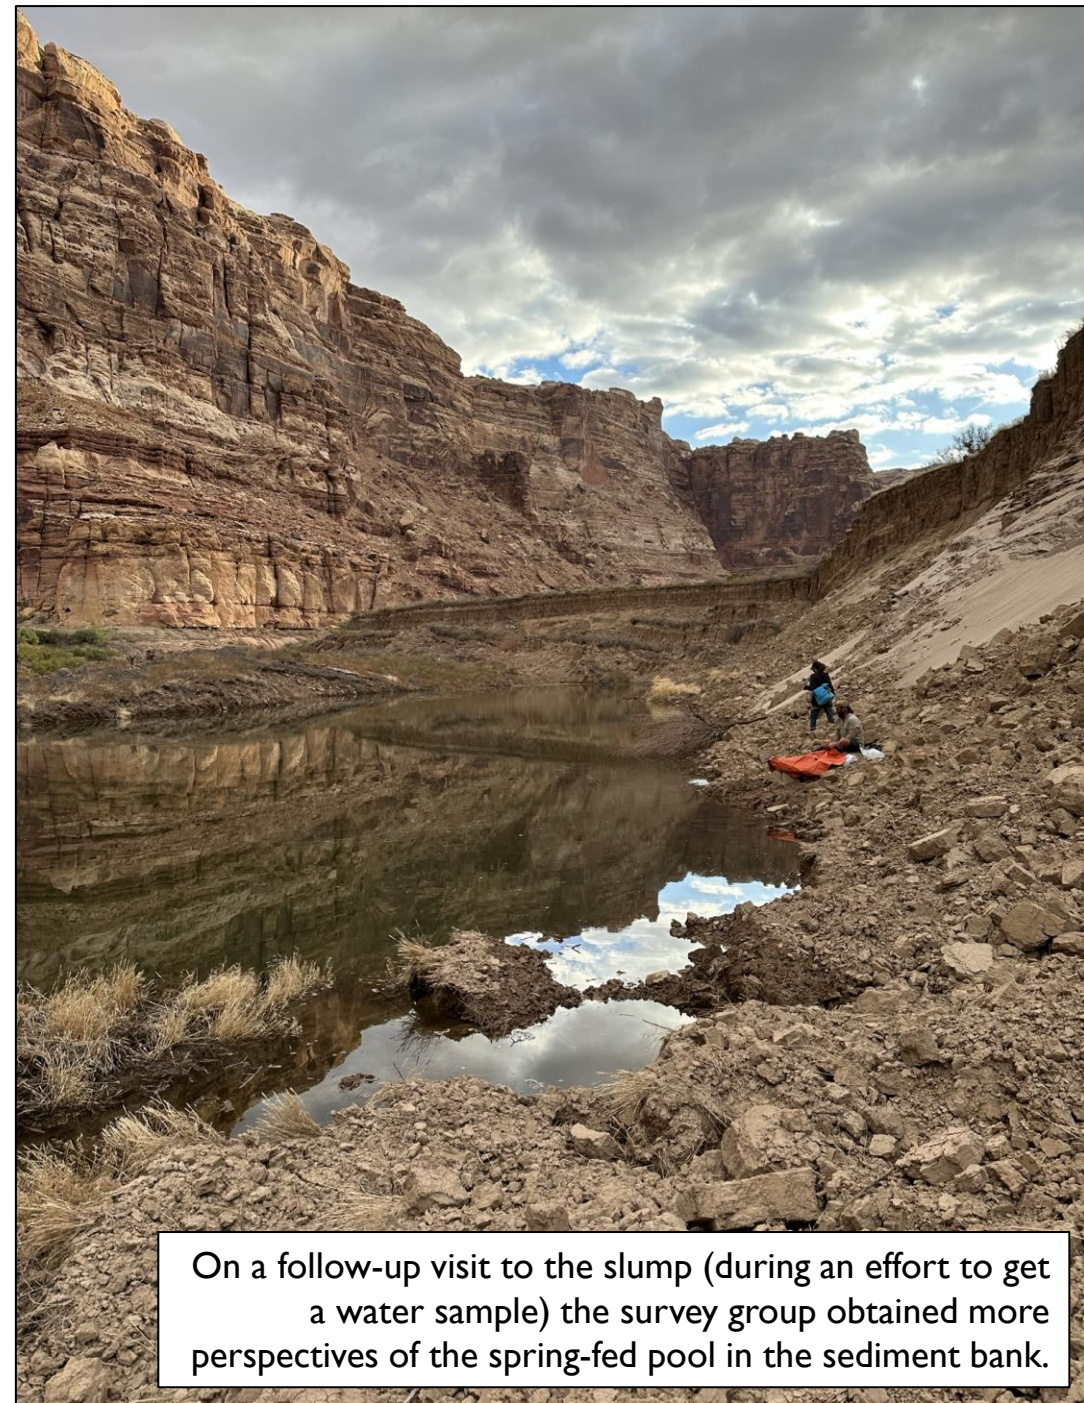
There were two springs that seemed to feed the pond in the slump.

One was fizzy with gas and did not seem to have much outflow (left). The other one appeared to be the main source of water (right).

Both springs were almost the same relatively cool temperature: 13.3 and 13.1 degrees Celsius (approximately 55 degrees Fahrenheit).

The pool itself was over 15 feet deep and did not appear to have an outlet to the river proper.

Spring sources in Slump Pond,
10-26-2023, both photos Meg Flynn

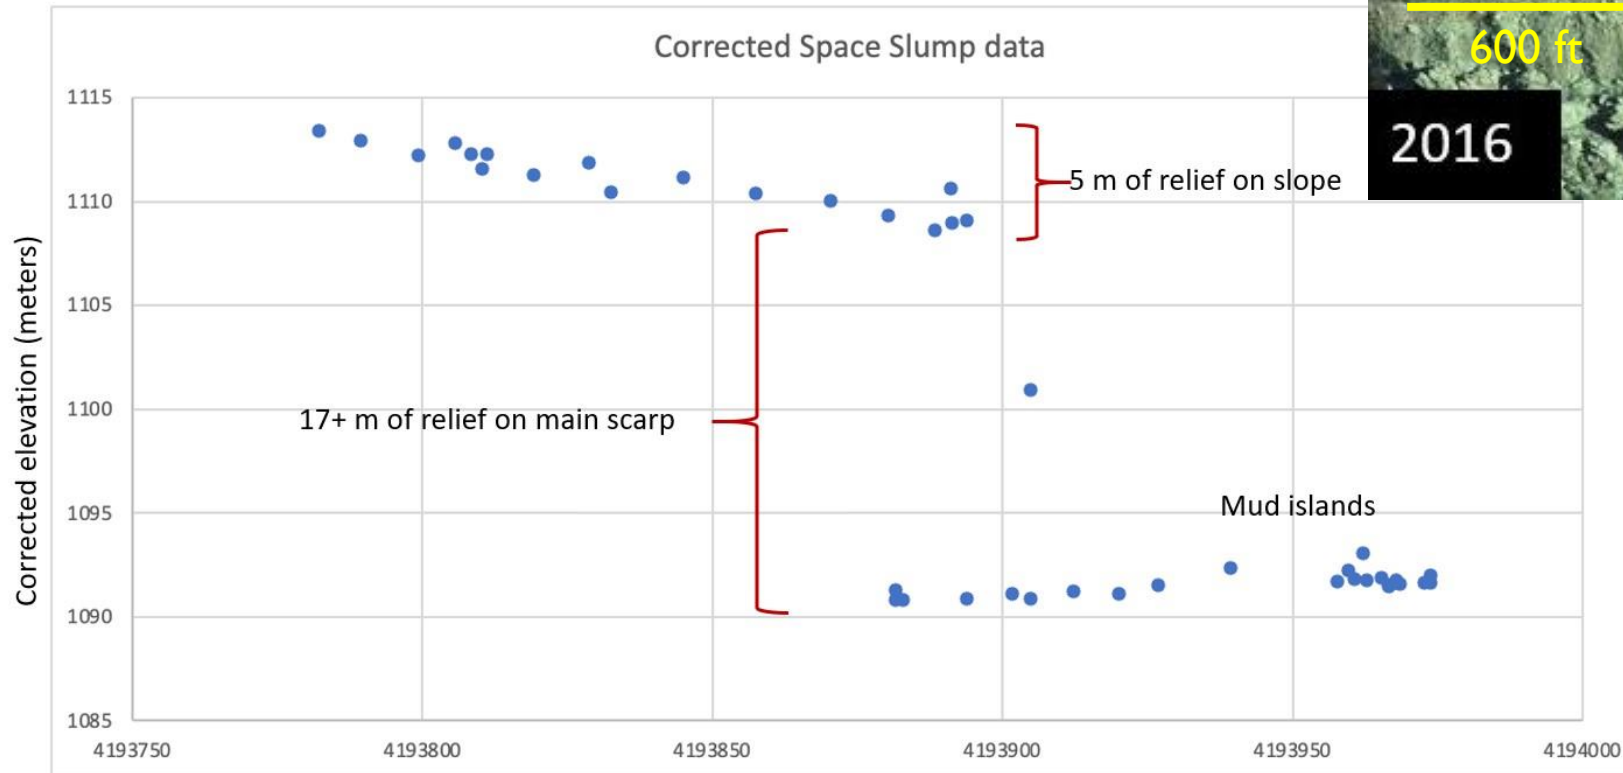
Survey points plotted to represent vertical relief showing how much the sediment terraces collapsed as they slumped towards the river.

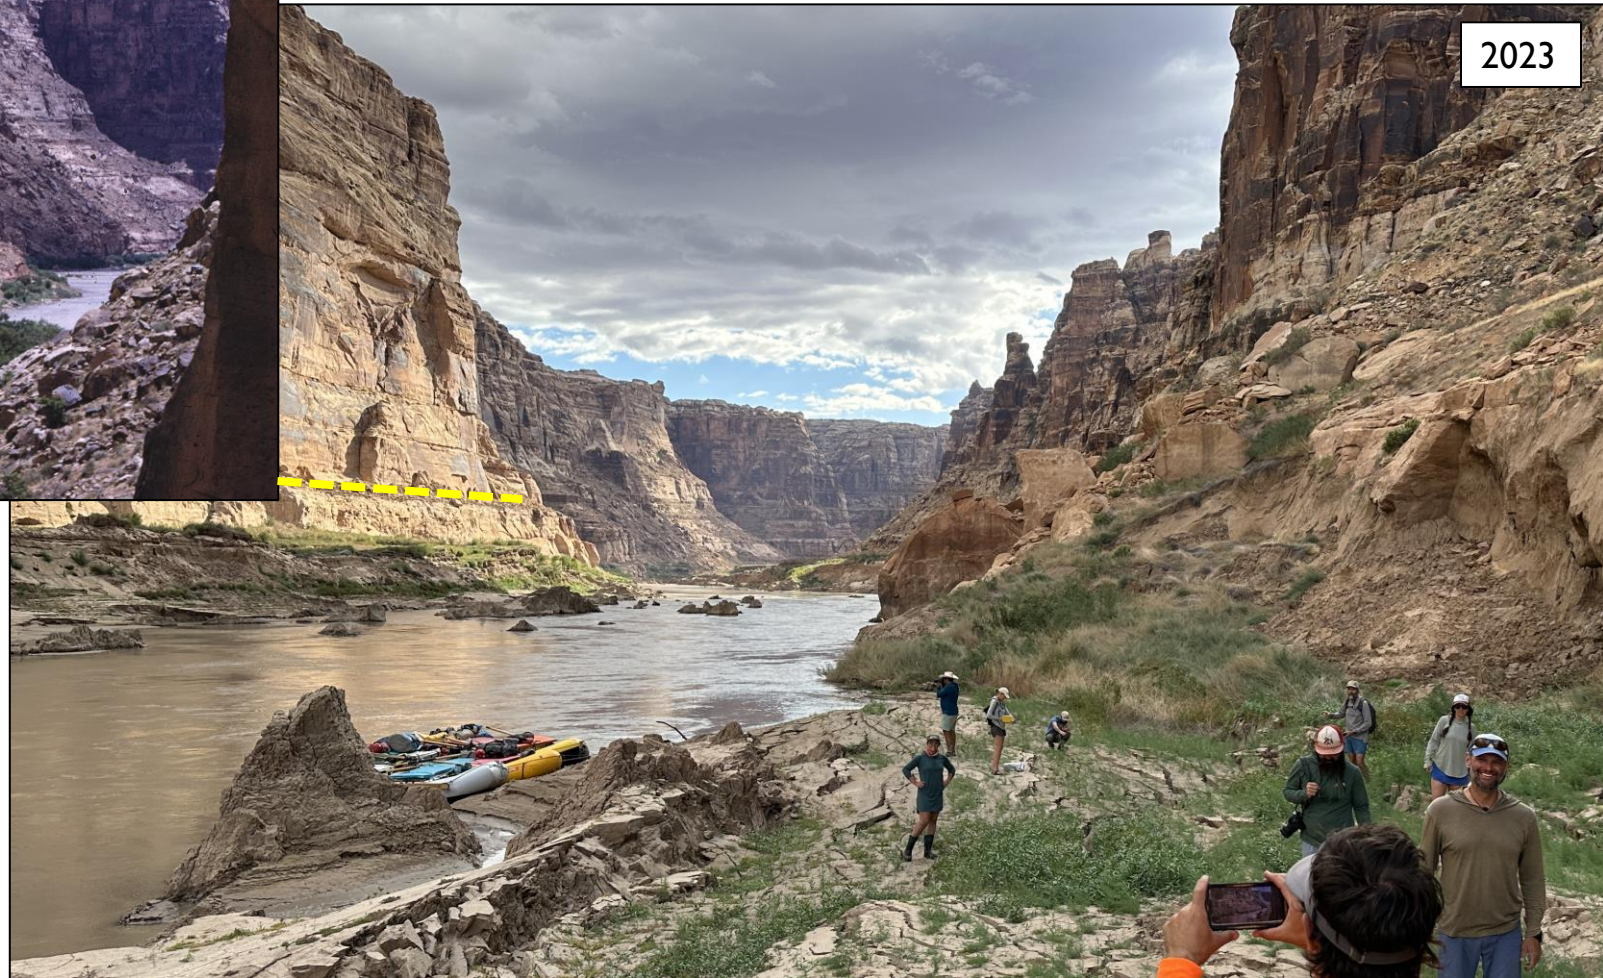
The North Wash Boat Ramp

The water surface elevation at the deteriorating access point just downstream from the Dirty Devil River dropped 6 feet this year.

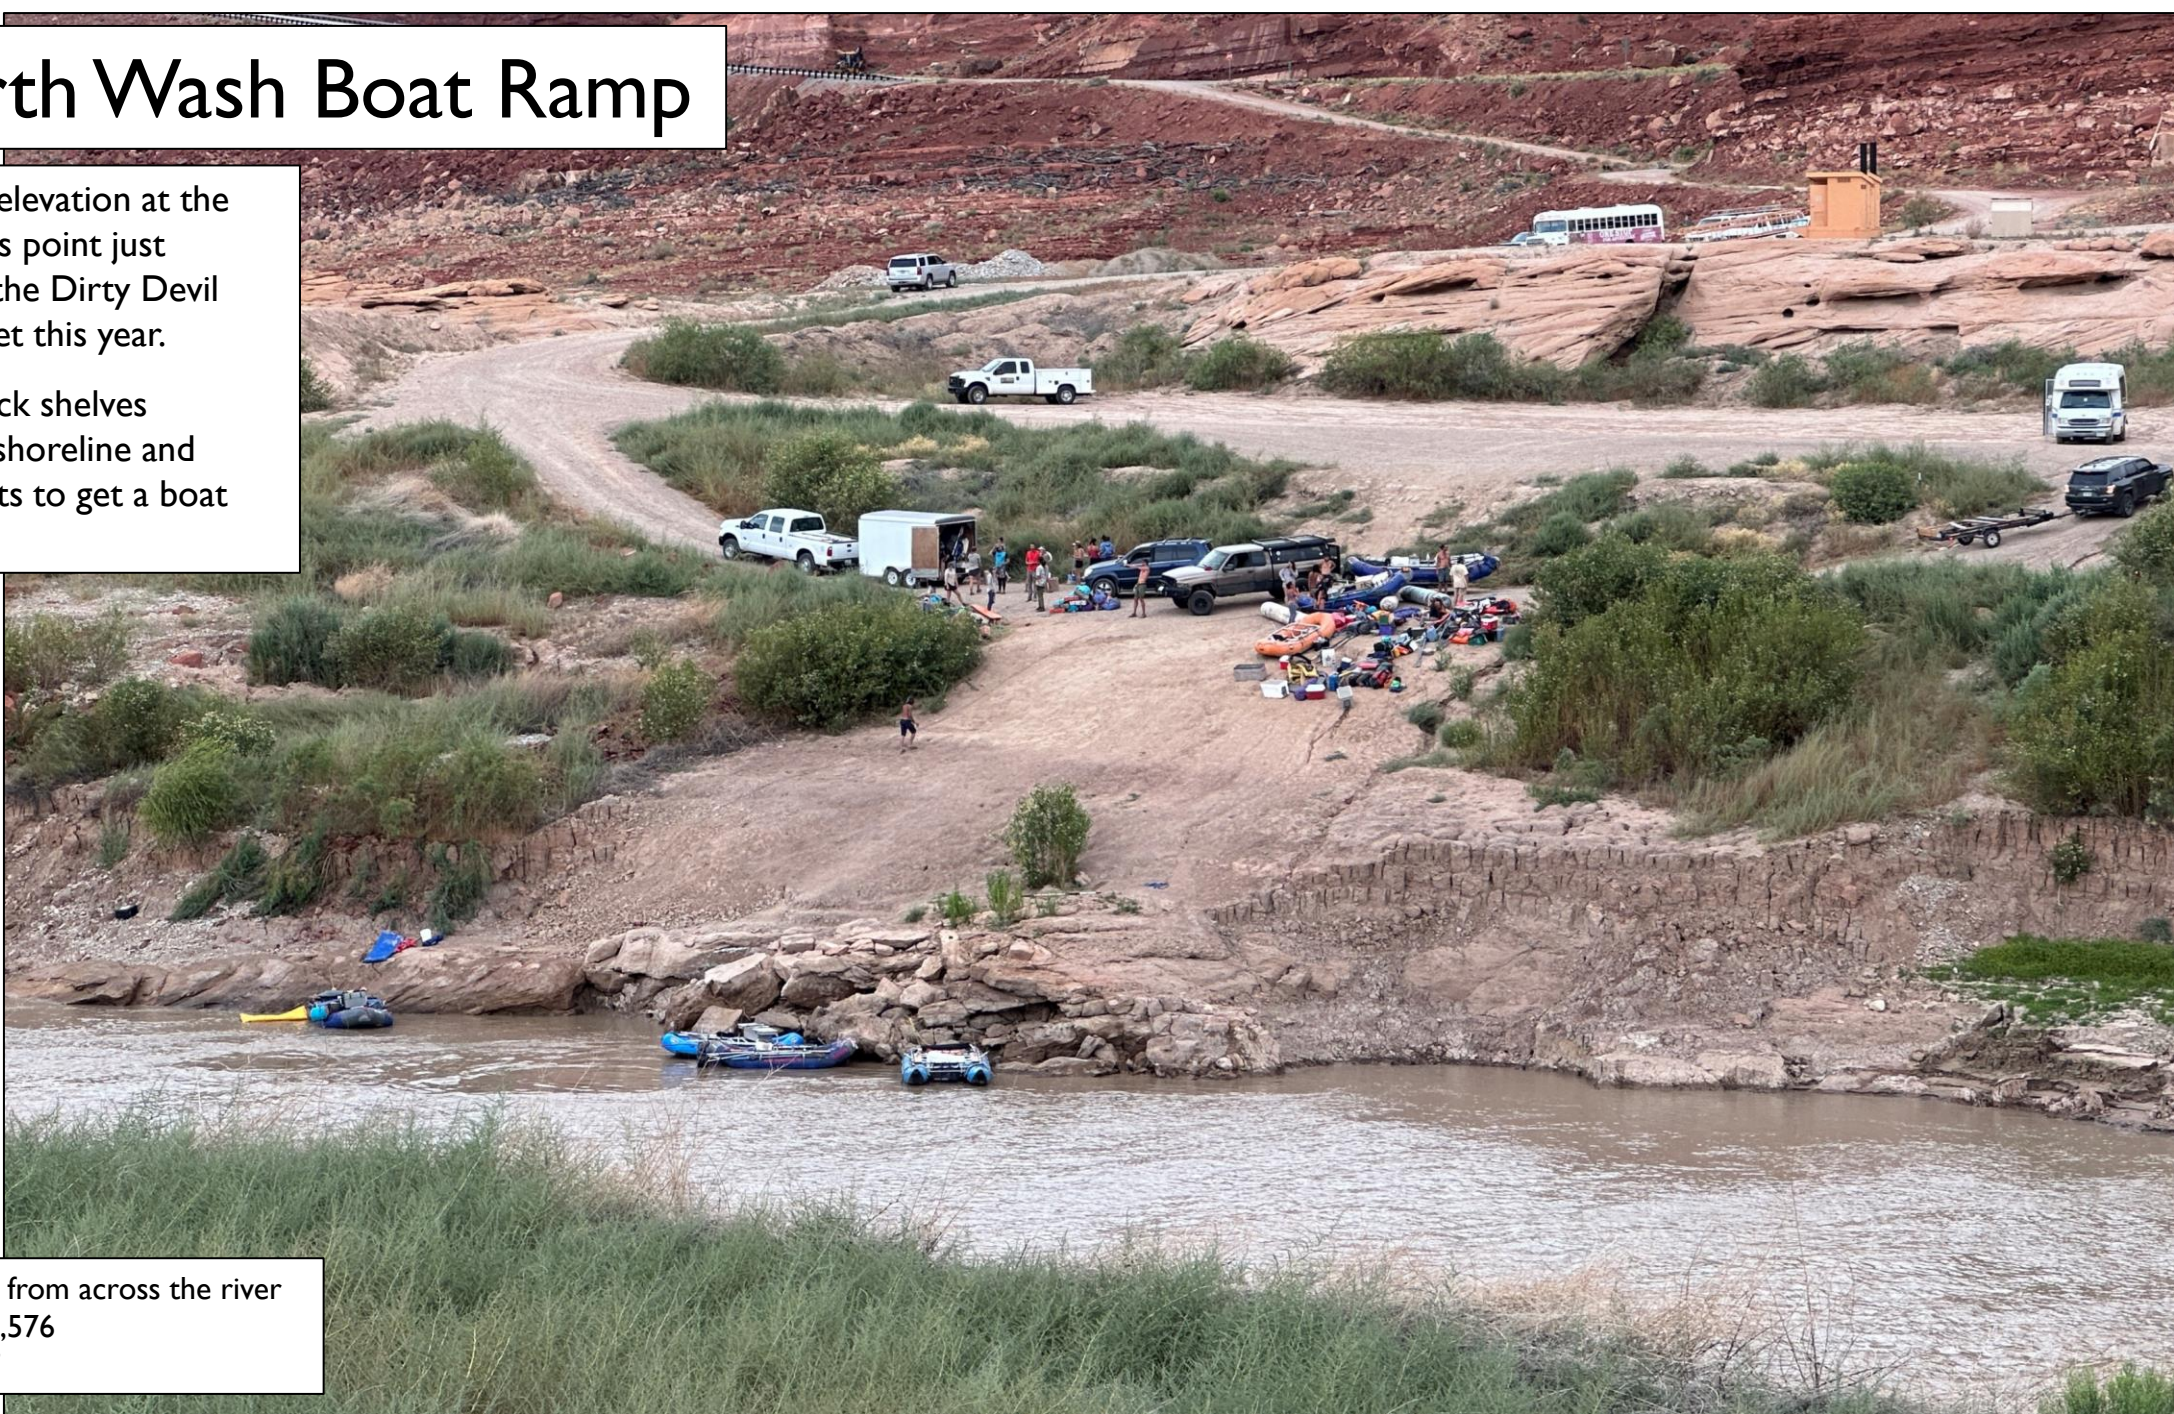
There are more rock shelves showing along the shoreline and fewer practical spots to get a boat out of the water.

North Wash Boat Ramp from across the river
6,400 cfs, bridge gauge 3,576
9-12-2023, Mike DeHoff

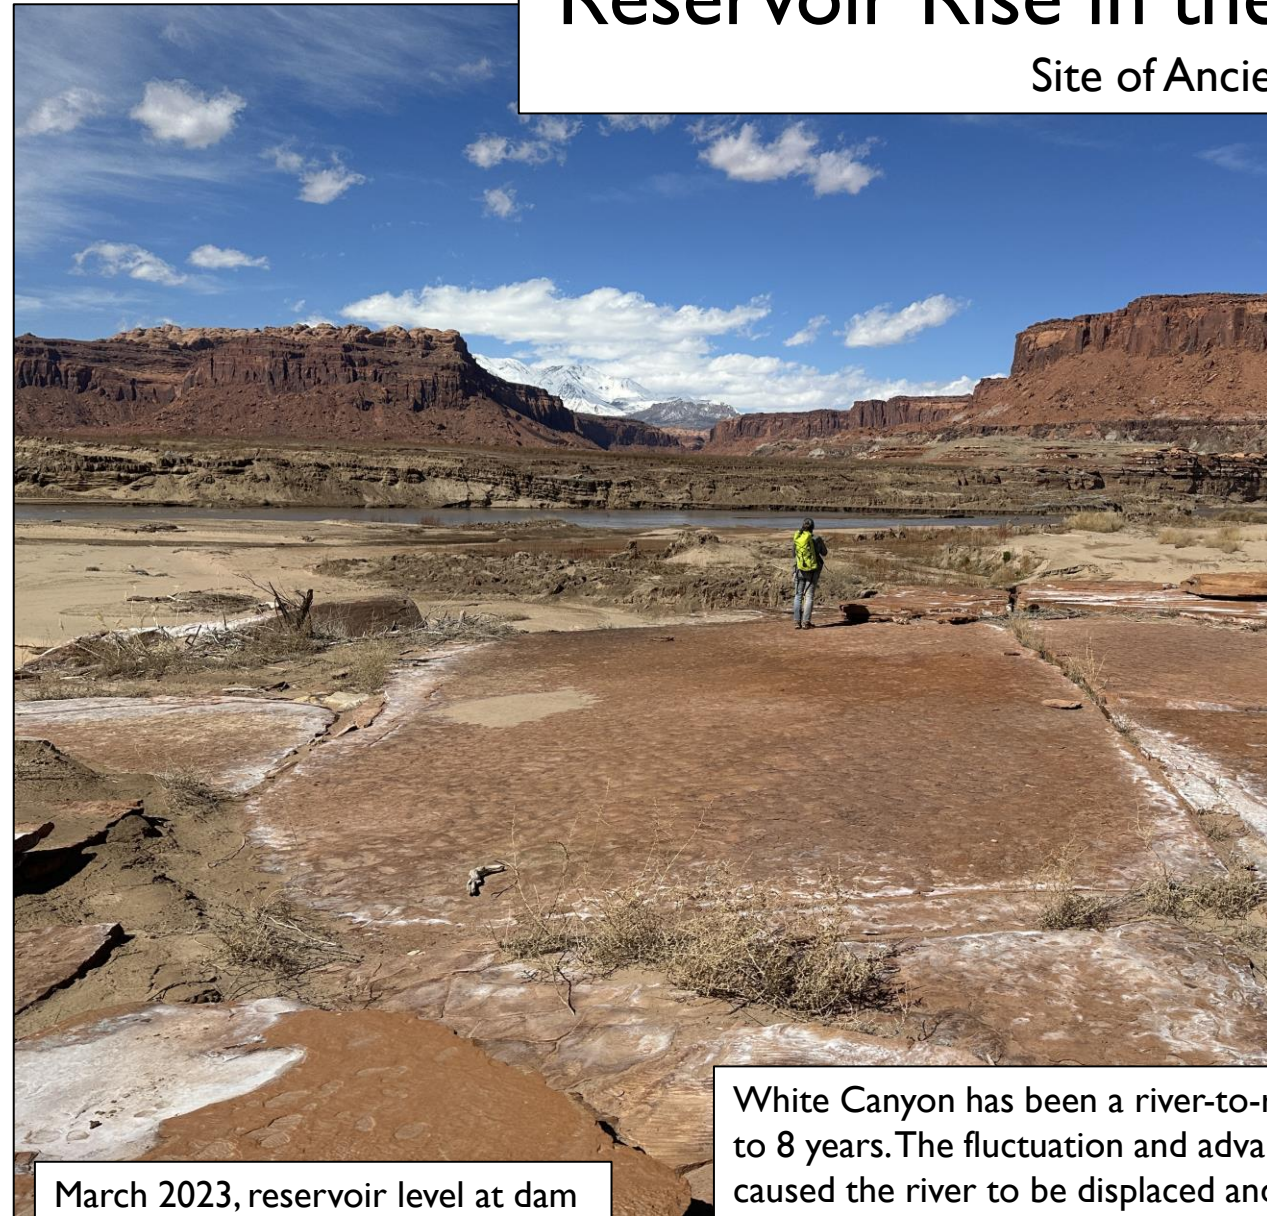
March 2023, reservoir level at dam
3,520 feet.

White Canyon has been a river-to-reservoir interface zone for the past 5 to 8 years. The fluctuation and advancement of the sediment deltas has caused the river to be displaced and historic and cultural sites to be damaged or destroyed.
