Returning Rapids

Fall Trip Findings

September and October 2023

2023 was a very dynamic year for Cataract Canyon. In September and October, the Returning Rapids Project (RRP) completed three Cataract Canyon research trips and one North Wash-based survey effort. This year, RRP has continued to monitor changes, build a data set, and communicate the story of what we are observing along this section of the Colorado River.

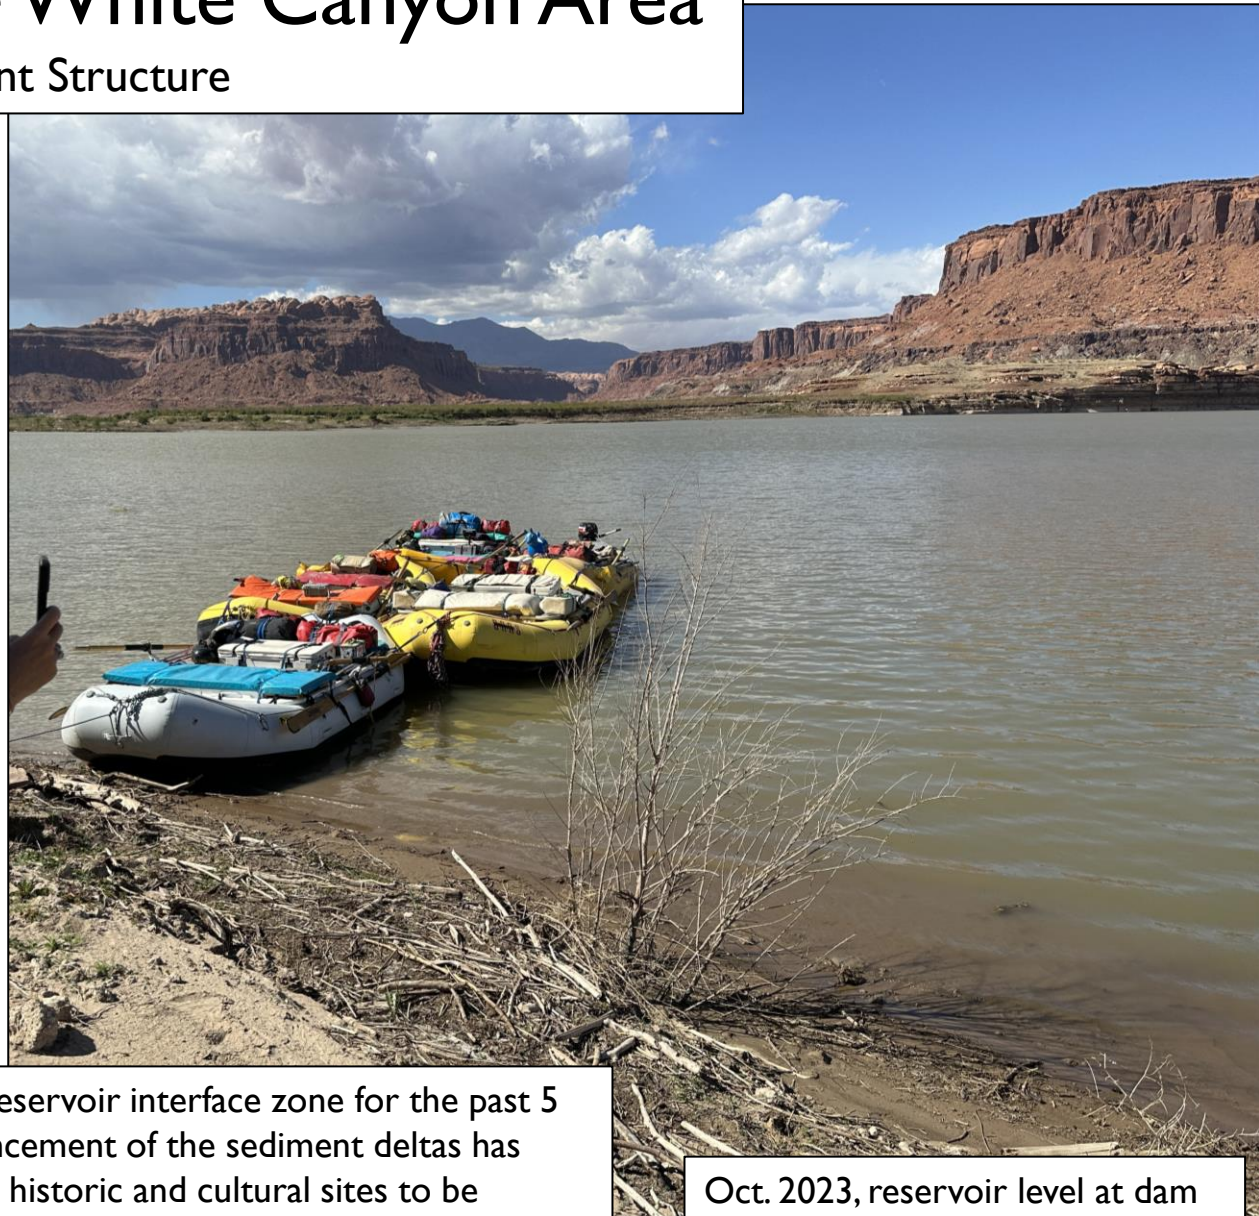
In 2023, the reservoir rose 65 feet and re-inundated this area.

As the reservoir fluctuates from year to year, it raises and lowers the water levels. This action has swept away ancient Pueblo structures, damaged rock art, and ruined inscriptions from historic river runners.

Oct. 2023, reservoir level at dam
3,573 feet.

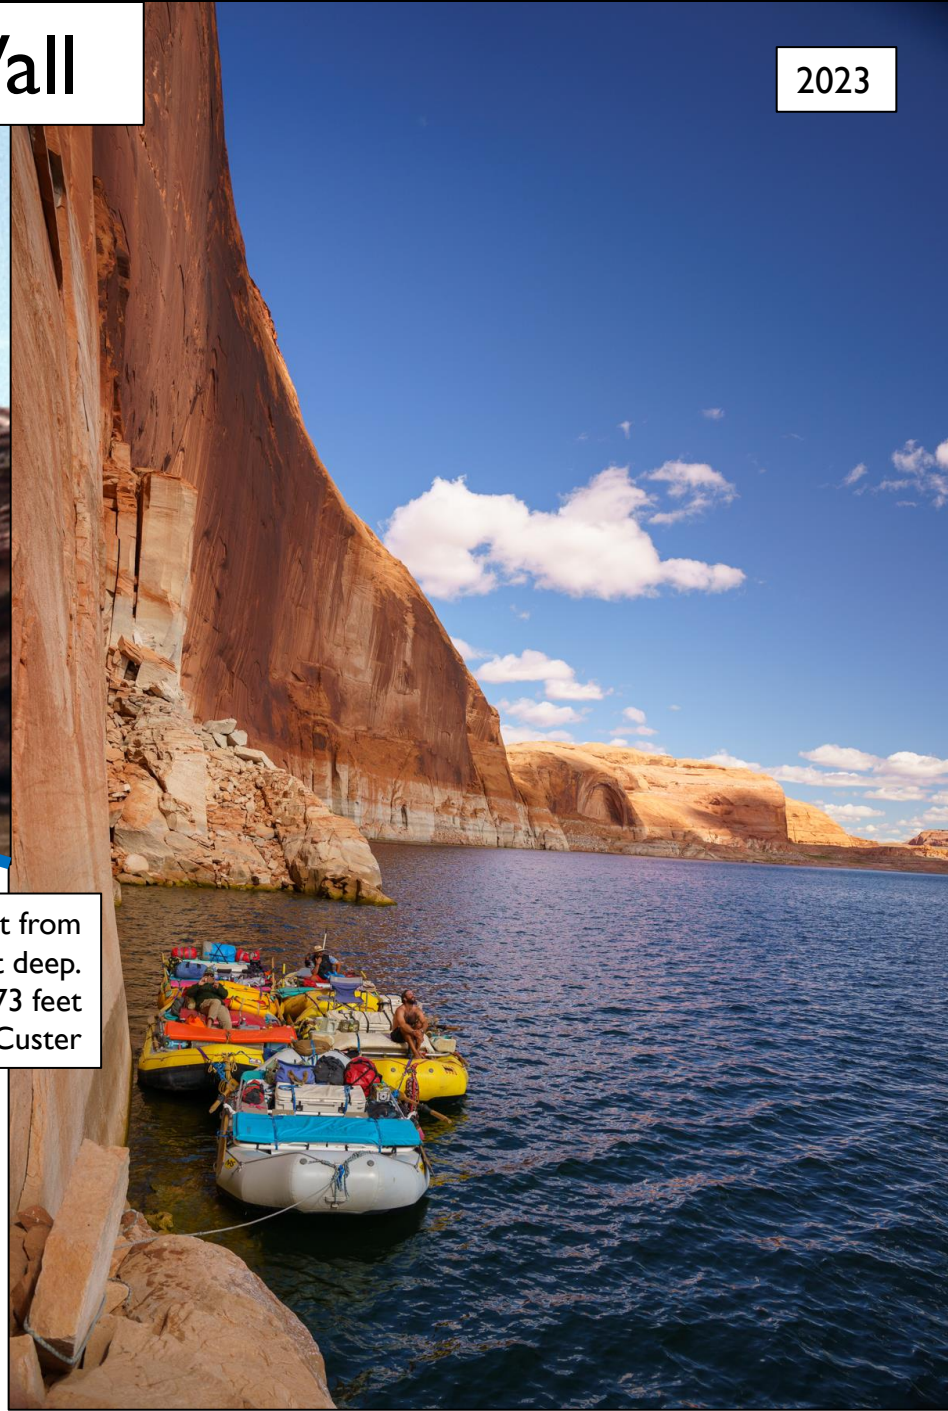
Tapestry Wall ledge stop. Depth finder reading just out from wall was 189 feet deep.
 Bridge gauge 3,576 feet, reservoir elevation at dam 3,573 feet
 10-12-2023, Travis Custer

Subtracting the depth finder reading of 189 feet from the water surface elevation at the dam (3,573 feet) gets a result of 3,384 feet, which is close to the pre-reservoir river elevation.
That means the sediment delta isn't here yet.
